RE: First Parish in Lexington: Historic Structures Assessment

Project Title: First Parish Lexington, Exterior Preservation and Structural Priorities

Project Title: First Parish in Lexington Meetinghouse, Exterior Preservation & Structural Repairs

Existing Conditions

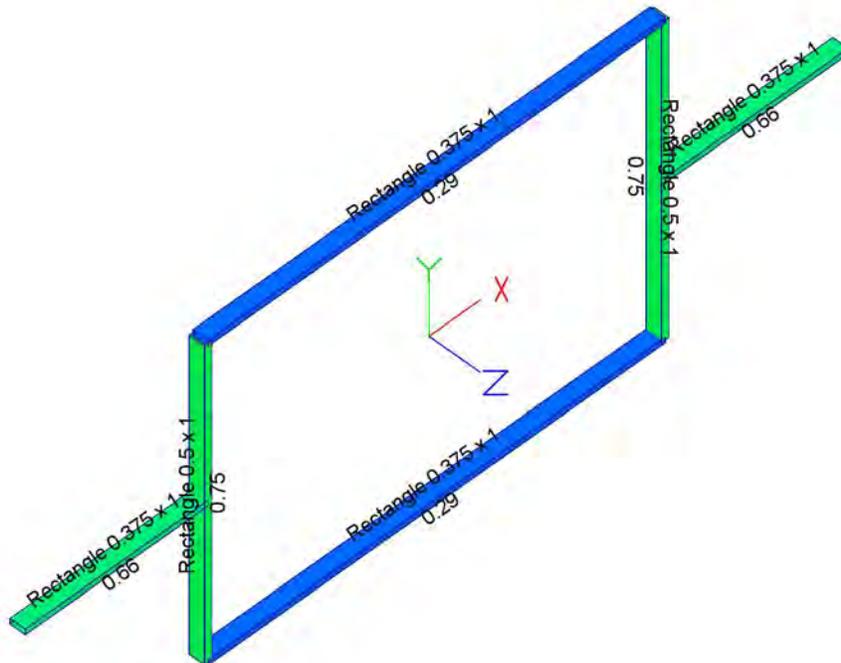
FPLEX-WB-1

A structural analysis of the historic window confirms that the distinct off-set grid of the muntins lacks the structural rigidity of a conventionally arranged grid of window muntins. As a result the twelve and a half foot tall by four and a half foot wide windows are subject to high stresses and may be susceptible to failure caused by wind loads. While no failures have been recorded, one hundred seventy years of aging have increased the potential for pressure and weather to adversely affect the sash.

Preliminary analysis of the muntin profiles and behavior (see attached sketch from MacCleod Consulting labelled FPLEX MP-1) suggests that an interior pair of braces for each window would mitigate the inherent design weaknesses without altering the visual character of the sash from the exterior. The braces would follow the line of the muntins, but provide the extra stiffening the windows require (see MacCleod Consulting sketch labelled FPLEX WB-1).

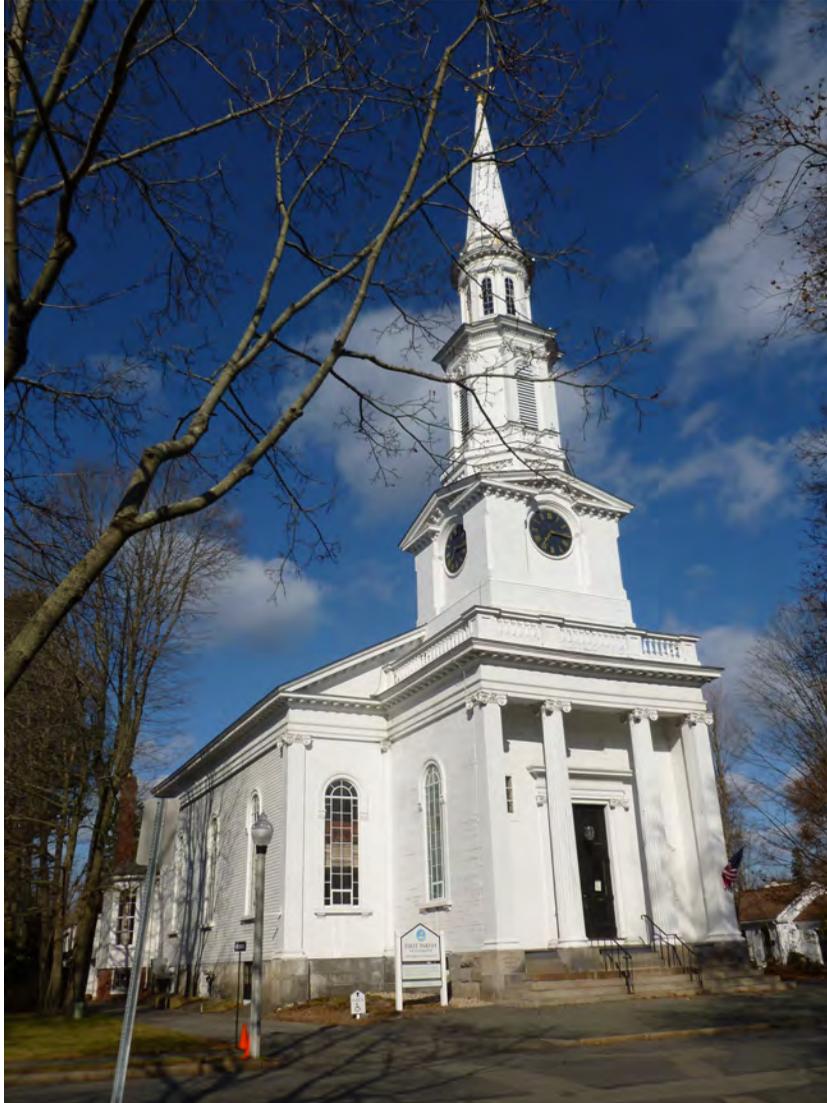
Facade (south elevation).

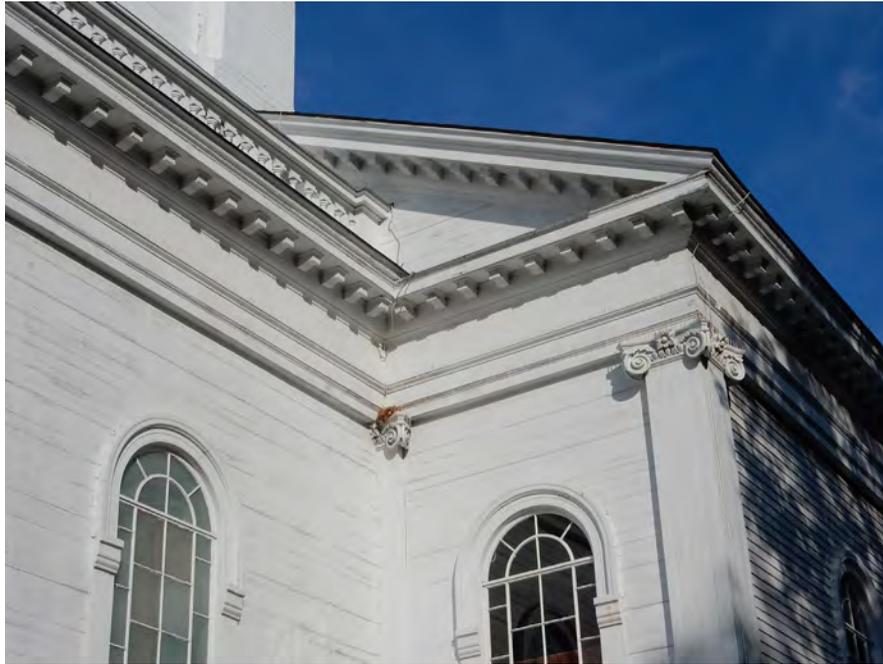
South and east elevations at portico junction with sanctuary. Note failed paint at flushboard siding and birdsnest at capital ornament.

2. Accumulated paint layers at the meetinghouse have led to the rapid failure of subsequent coatings. Strip, prime and repaint exterior with historic color informed by paint analysis. Perform selected repairs to historic wood trim, details of which are expected to be revealed by the paint removal. Persistent peeling paint at the spire will be addressed by pre-etching the lead coated copper and proper priming to achieve paint adhesion.

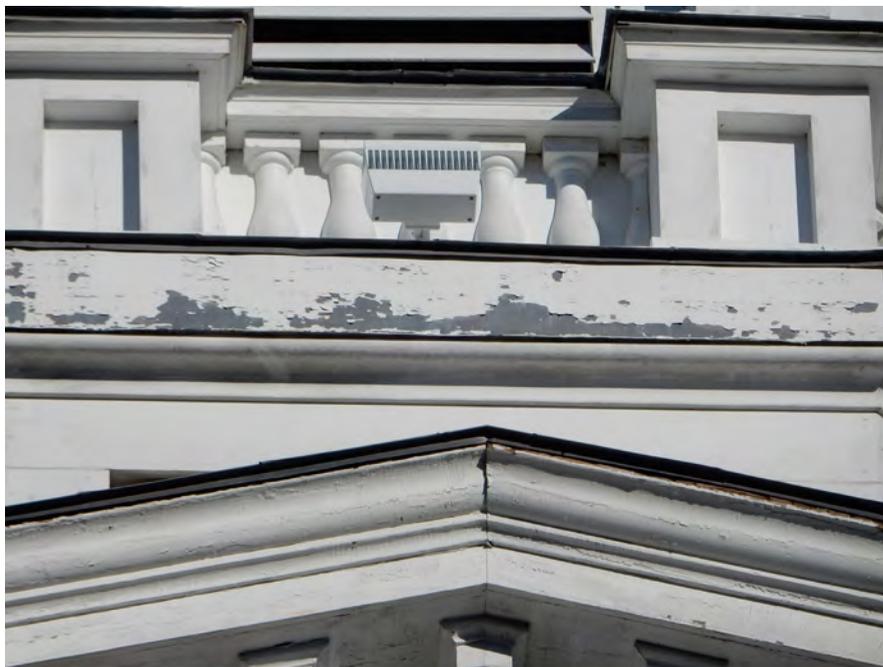
Facade (south elevation). Failed paint at tower base.

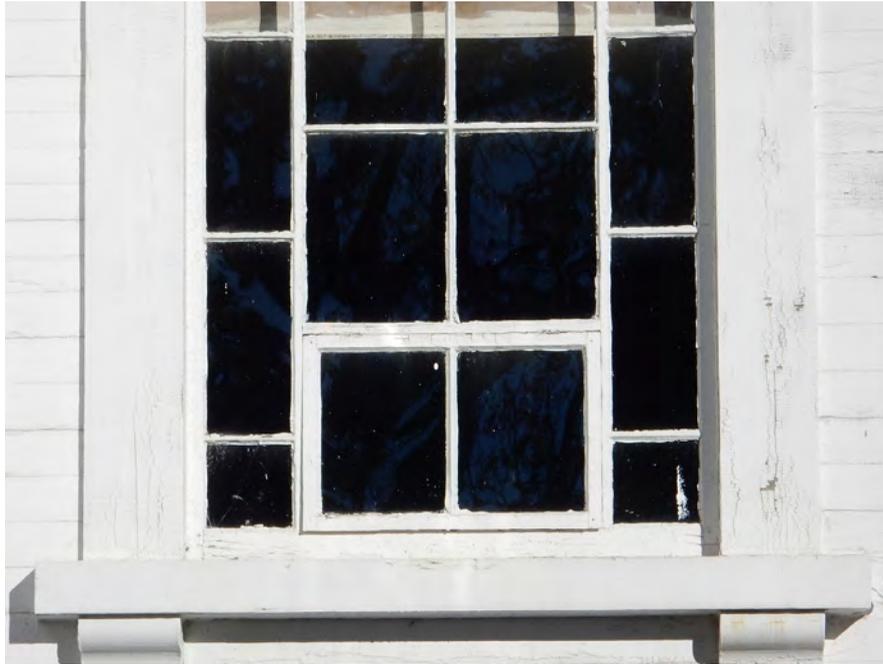
The large Romanesque windows in the original building have an unusual arrangement of muntins. The vertical muntins span about 12 feet. The horizontal muntins across the 4.5-foot width are not continuous, but stagger in alignment. The 12-foot span is simply too long to provide adequate support. The support should have been designed for the shorter horizontal span. This can be mitigated with a storm window with glass thick enough to

Historic window. Note layered paint and failed glazing at muntins and cracked, peeling paint at surround.

1. Repair and restore the meetinghouse windows. The original window design features staggered muntins, an arrangement that provides inadequate overall structural support. This will be mitigated by the introduction of grid braces and the installation of storm windows once the wood repairs are complete.

span the 4.5-foot width. Alternatively, a metal muntin grid at the third points of height that fits the staggered pattern could strengthen the existing muntins.

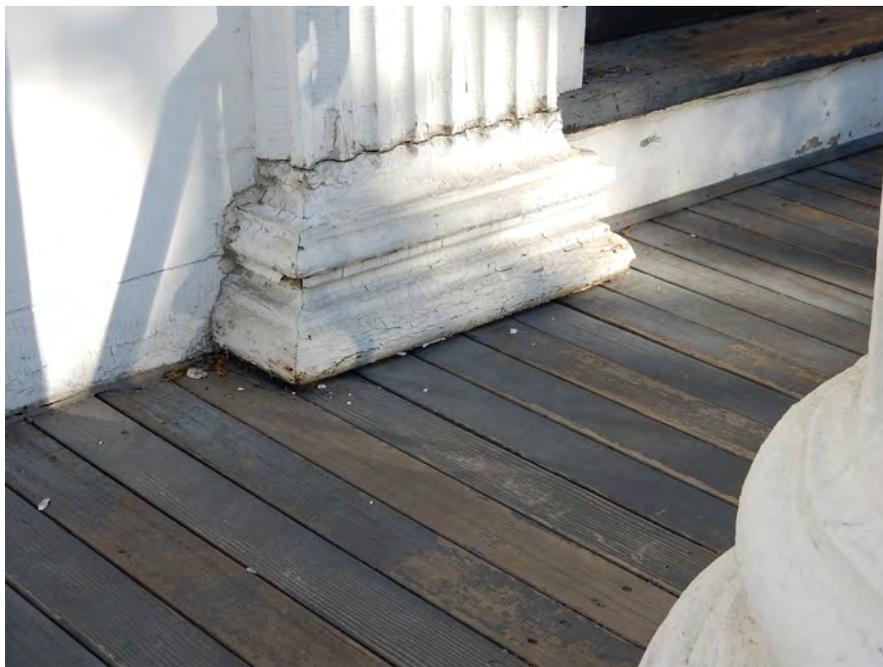
Square column base at portico. Note failed paint and wood rot at trim and worn finish at porch floor.

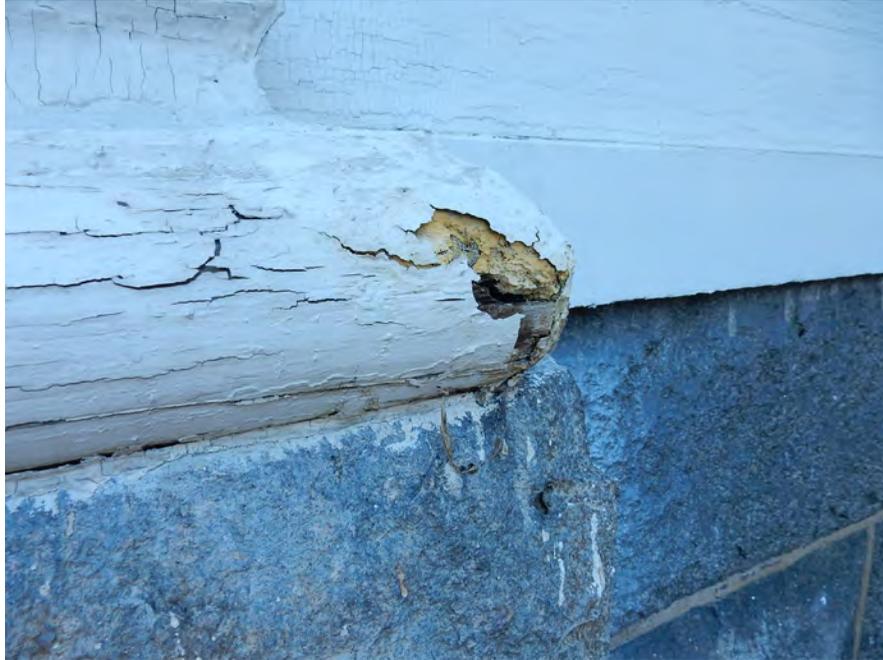
Column base at portico. Note rotted wood and failed paint.

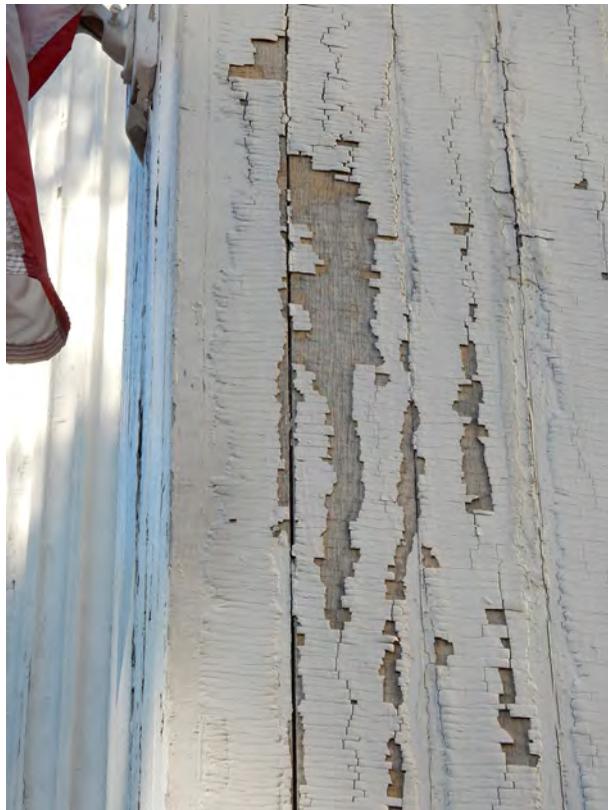
Square column at portico. Not failed paint.

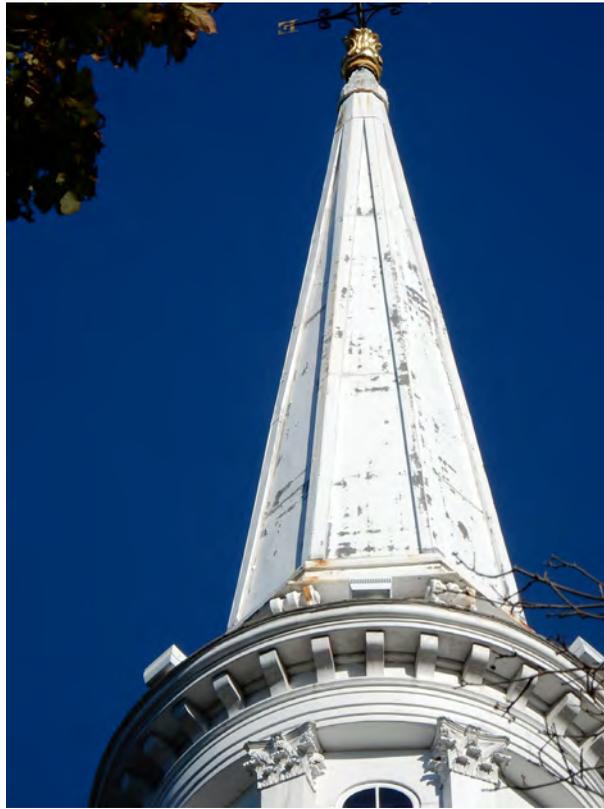
Failed paint coating over leaded copper at spire.

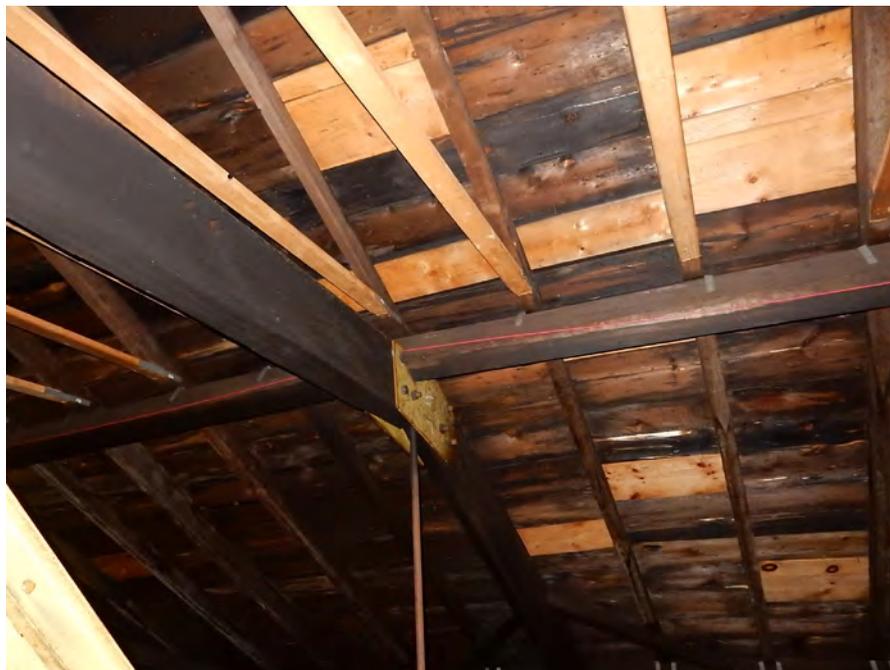
The roof is supported with timber trusses supporting timber purlins which in turn support wood rafters. The rafters are adequate. The trusses which were reinforced with steel about 90 years ago should be adequate. The two uppermost out of six lines of purlins support more than half the roof. My preliminary evaluation is that these are overstressed but can be strengthened by sistering LVLs to their sides.

Attic framing. Stressed purlin seen behind red electrical wire.

3. Make structural repairs to the meetinghouse roof by sistering LVLs to the sides of the uppermost, overstressed purlins.

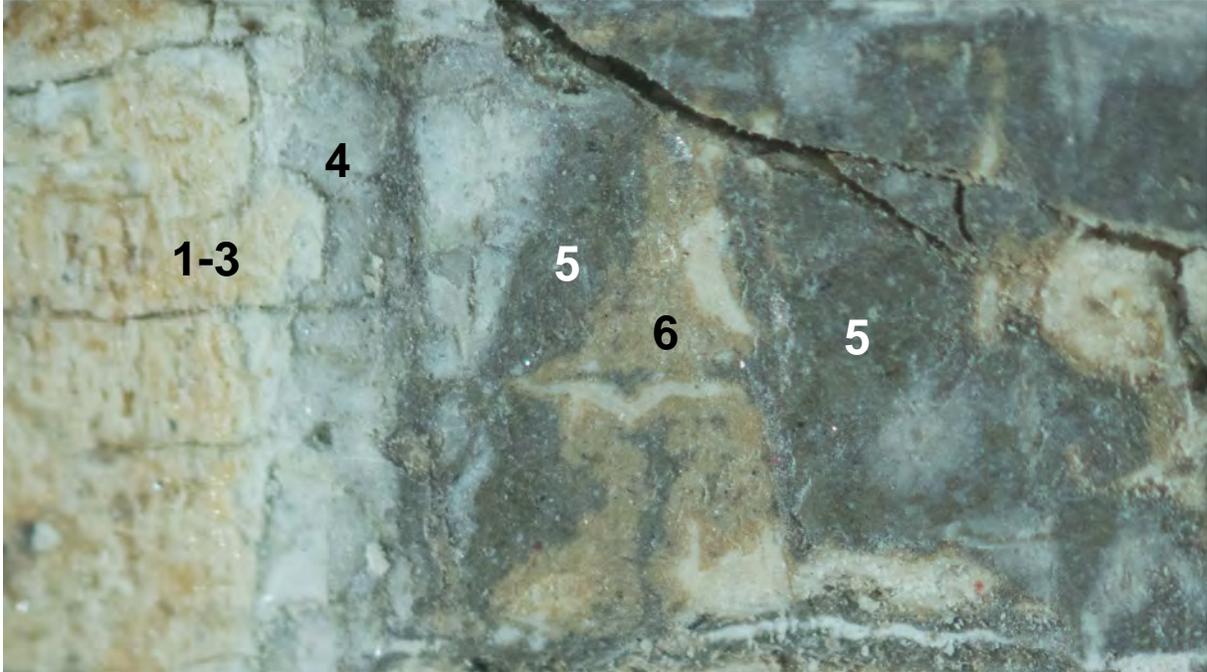
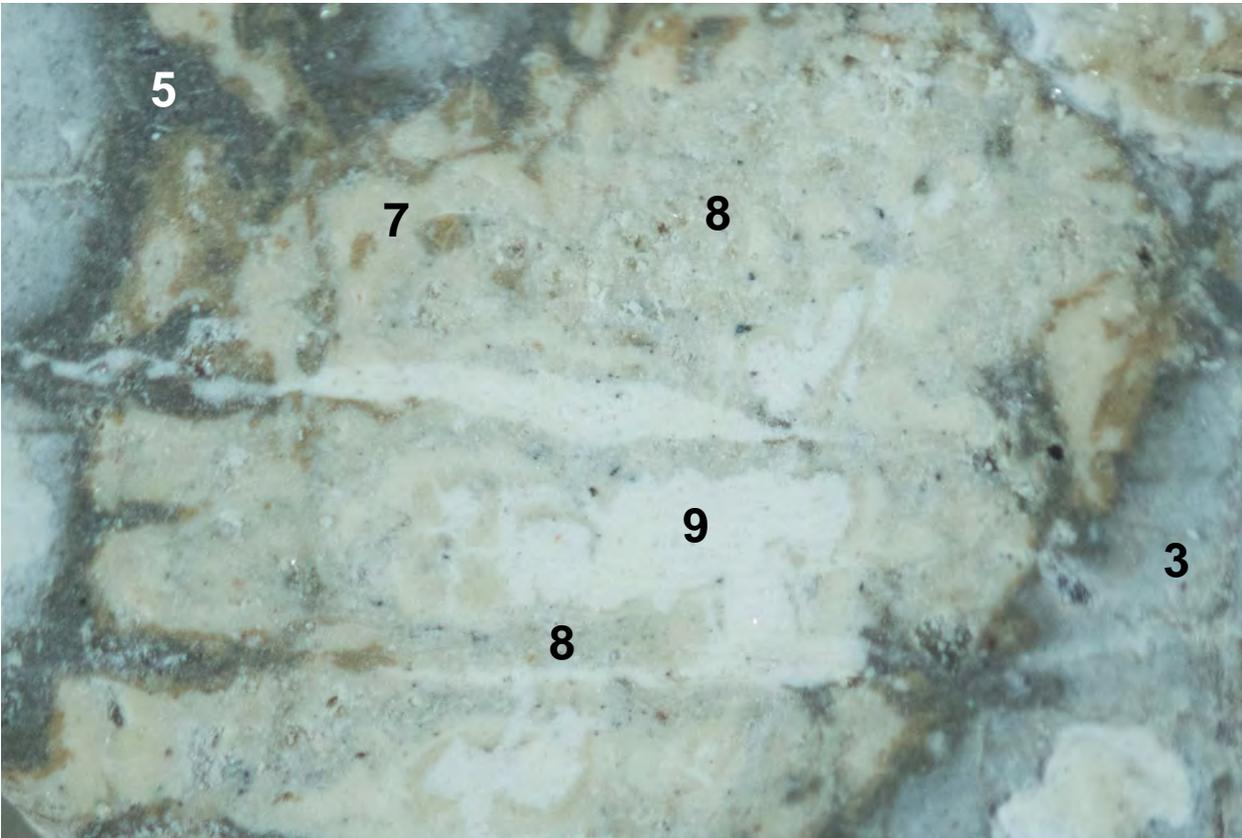
Paint sample from Lexington Church prepared from the backside of the sample (i.e, working from the oldest layer down rather than from the current finish back. #s refer to #s in my email. Needless to say the appearance of the colors in the photo is very approximate.
