Historic Structure Report  
**The Hammond A. Hosmer House**  
Lexington, Massachusetts  
BH+A Project No. 2991.00

Prepared by: Bargmann Hendrie + Archetype, Inc.  
300 A Street  
Boston, MA 02210  
617-350-0450

Prepared for: Town of Lexington  
Department of Public Facilities

November 30, 2010

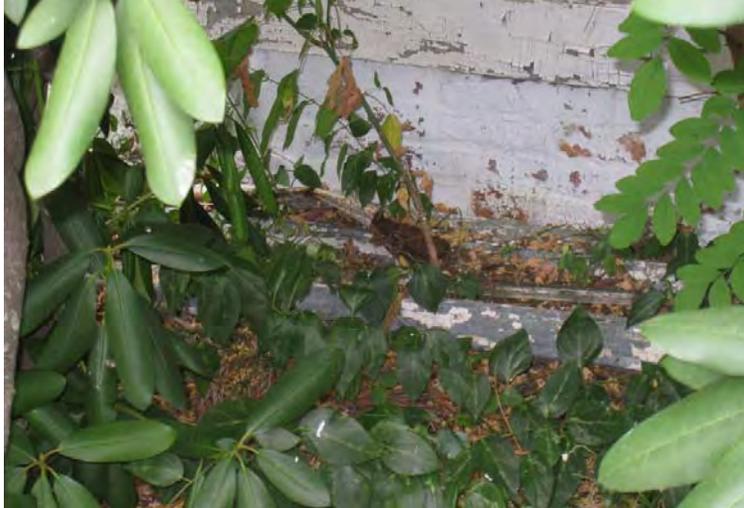
Photo 2.1-7: Peeling paint at brick foundation at south elevation.

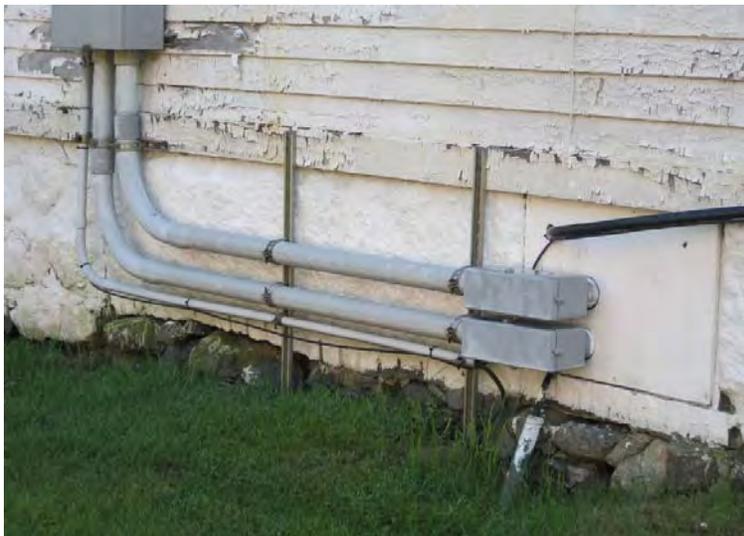
Photo 2.1-8: Boarded up window at electrical service entry, west elevation. Note holes in stone rubble wall below stone block.

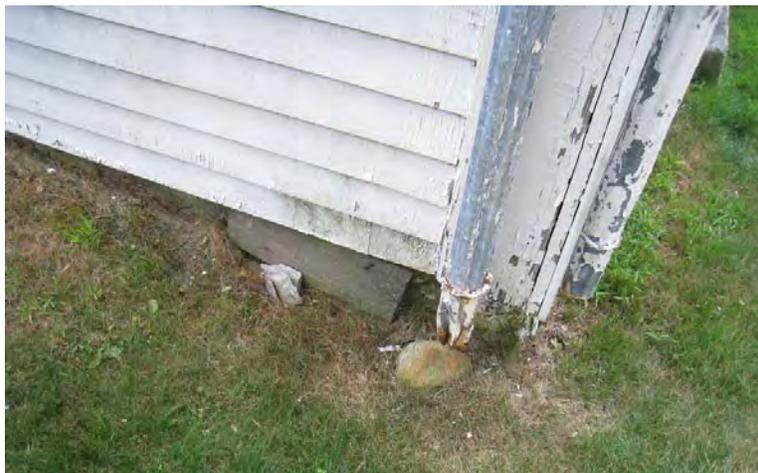
Photo 2.1-9: Board nailed over hole at northwest corner of Barnes addition foundation.

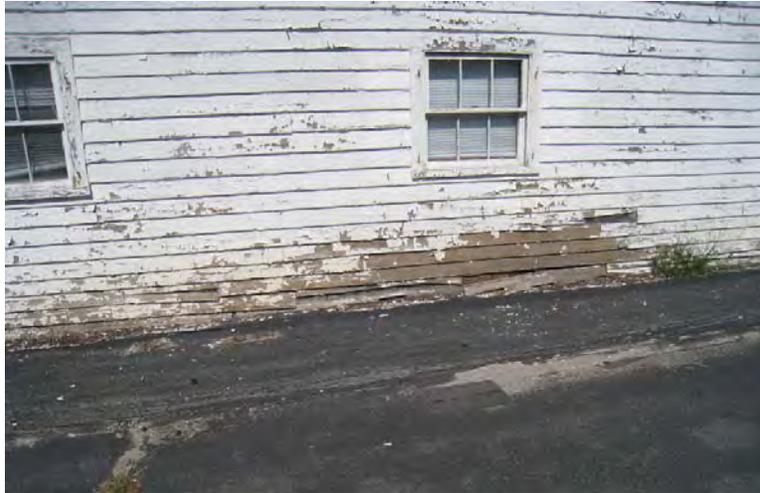
Photo 2.1-10: Rotted wood siding where siding touches grade at east wall of barn.

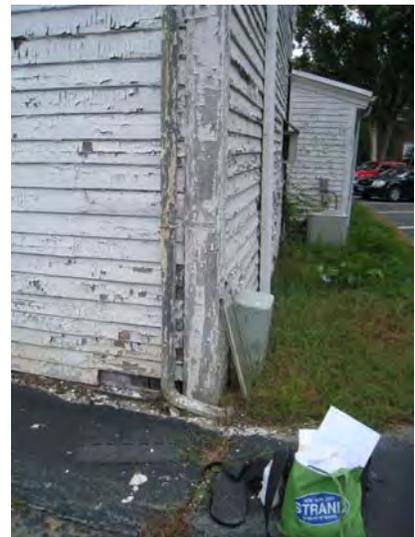
Photo 2.1-17: Deteriorated clapboards and corner board at northeast corner of barn.

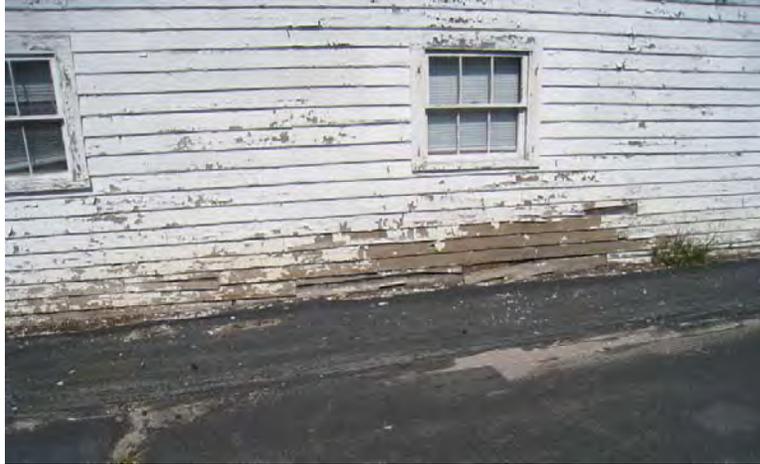
Photo 2.1-18: Area of deteriorated clapboards at east elevation of barn.

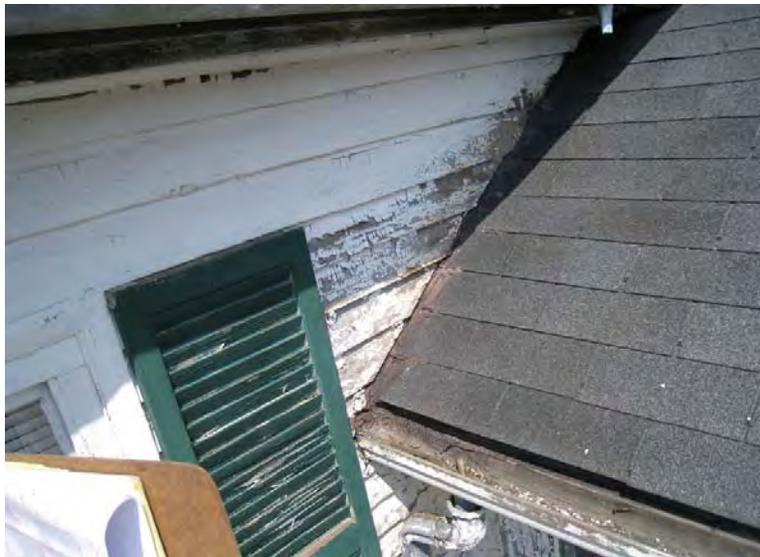
Photo 2.1-19: Deteriorated siding at junction of north ell wall and south east ell roof.

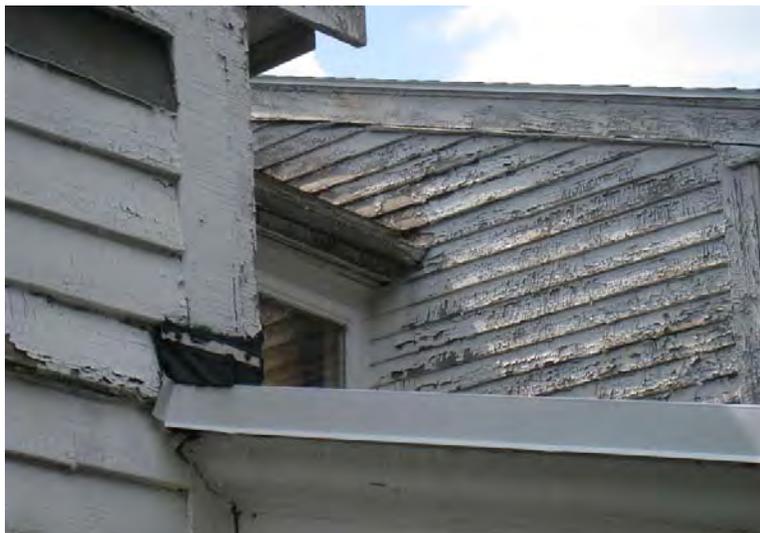
Photo 2.1-20: Deteriorated siding at the east wall of the "pop-out" extension of the east ell at the north elevation where it abuts the second floor east ell roof.

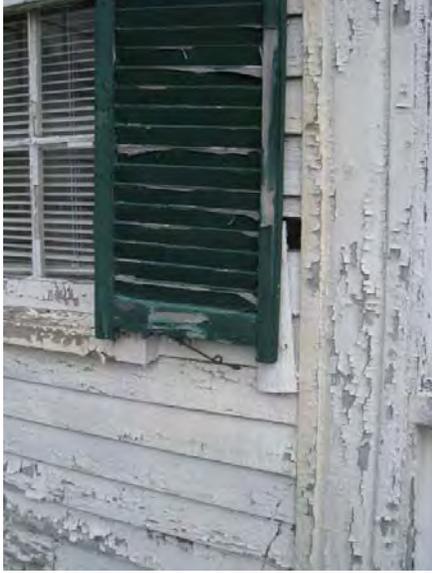
Photo 2.1-21: Deteriorated siding adjacent to south east ell door.

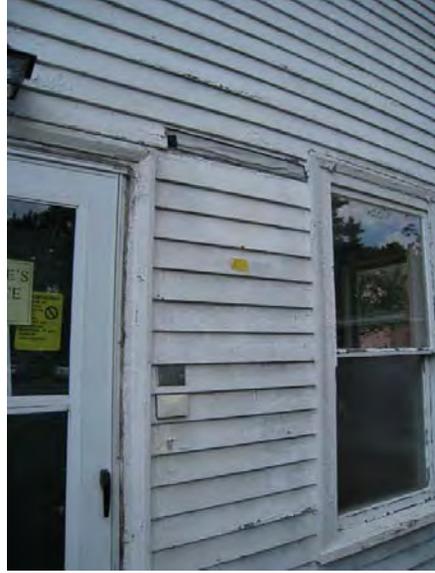
Photo 2.1-22: Missing siding board above the north door of east ell with building paper installed in opening.

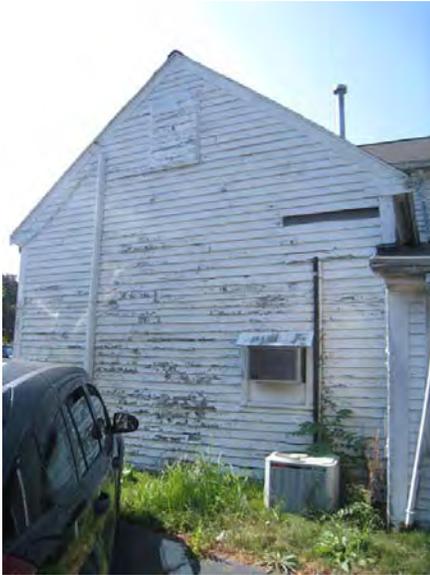
Photo 2.1-23: Missing siding board at the north elevation of barn, with building paper installed in opening.

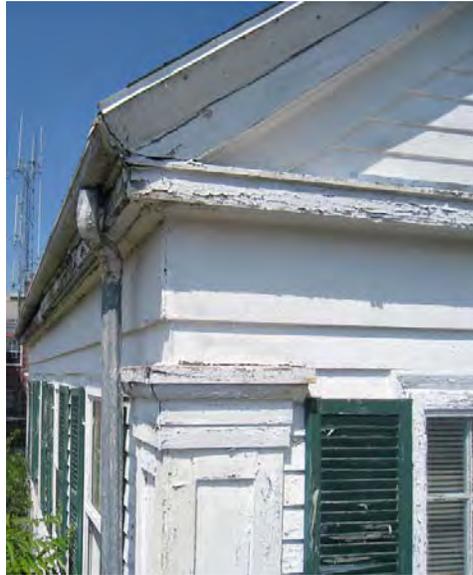
Photo 2.1-24: Split at mitered corner of pilaster cap, southeast corner of main block.

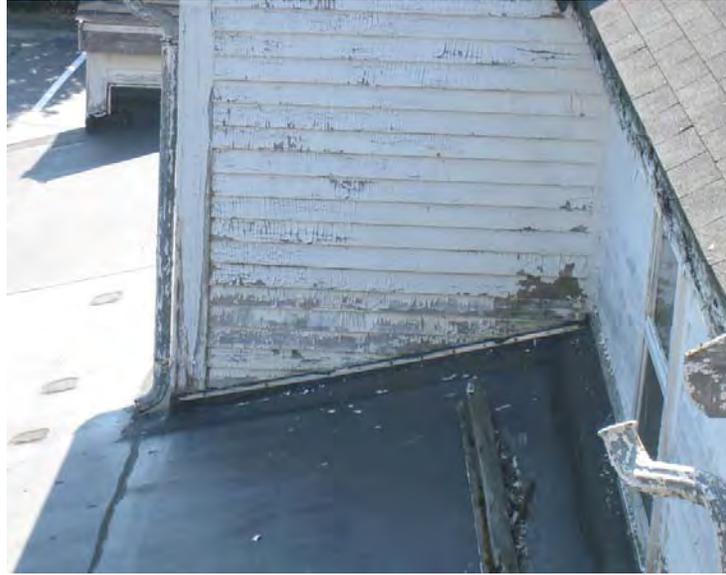
Photo 2.1-54: Termination bar nailed to siding above east ell north shed roof. Note deteriorated gutter that has fallen off the eave of the second floor roof above.

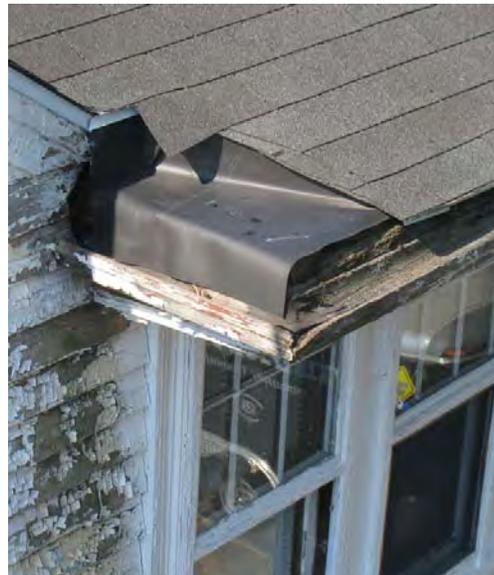
Photo 2.1-56: Deteriorated area of soffit, northeast corner of Barnes addition.

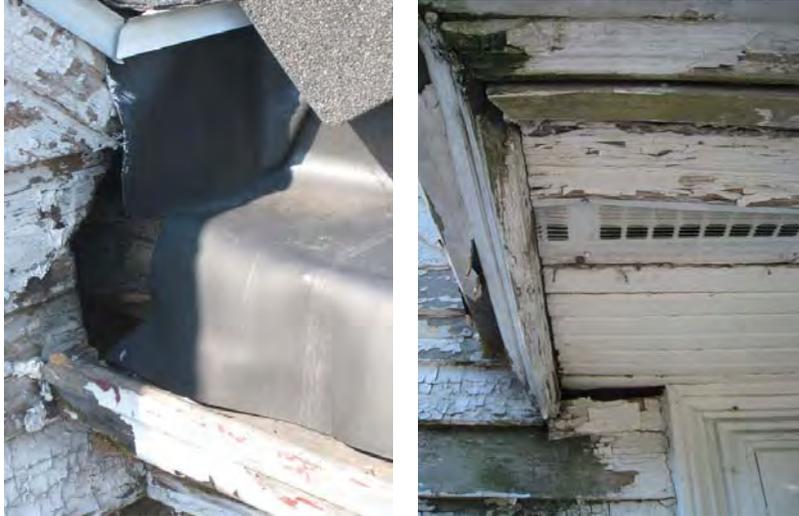
Photo 2.1-57: Hole in siding and rotted gutter where Barnes addition soffit meets building wall note that the edge of the EPDM roofing patch funnels water into this hole.

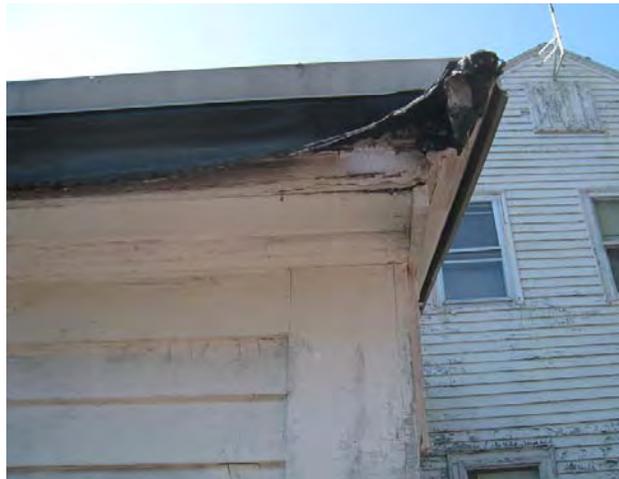
Photo 2.1-60: Turned up corner of EPDM roofing at northwest corner of east ell shed roof.

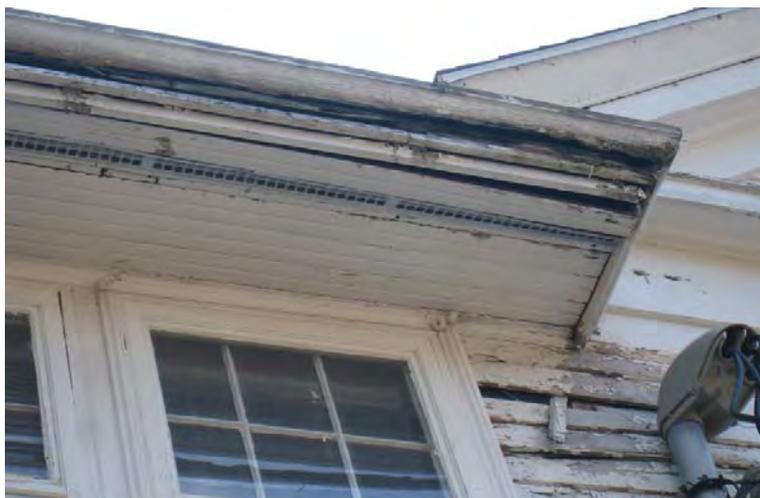
The wide soffit at the Barnes addition is particularly problematic. In addition to the area of deterioration at the northeast corner of the soffit noted above there is also severe deterioration at the northwest corner and the southwest corner of the soffit where it turns to meet the wall of the main block at the west elevation. One of the soffit boards at this location is detached, and there is a hole in the gutter above (Photo 2.1-64).

Photo 2.1 64: Deteriorated soffit at south side of Barnes addition, west elevation.

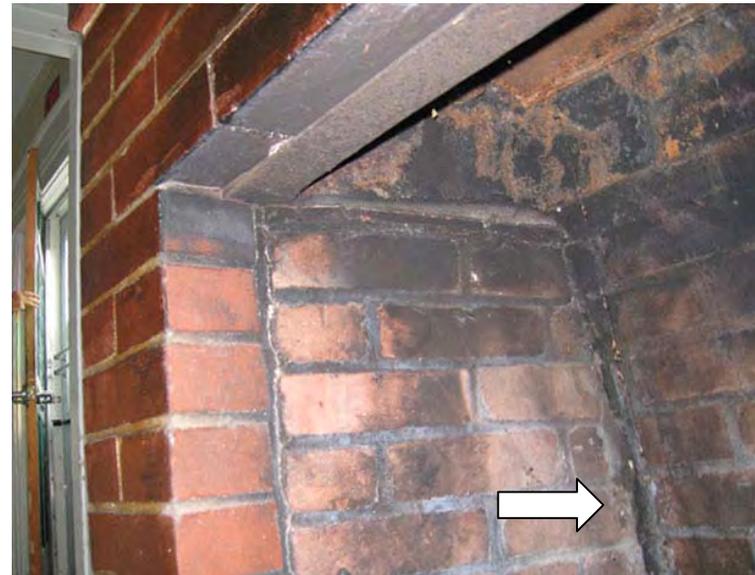
Photo 2.2-3: Door opening between Room 101 and Room 102. Note hinges at Room 102 side.  
Photo 2.2-4: Crack at back corner of firebox. Also note steel lintel at opening in firebox surround.

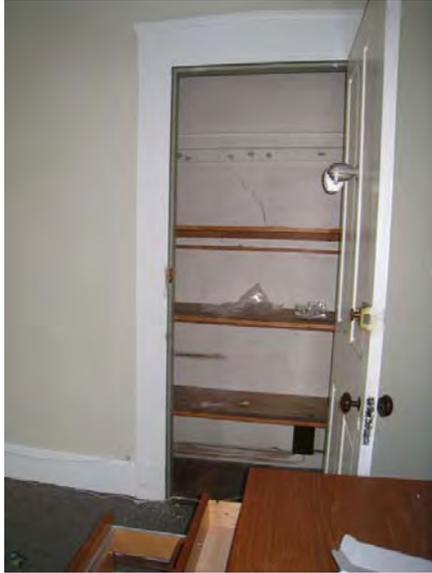
Photo 2.2-13: Cracks in plaster wall at the back of the closet in Room 201  
Photo 2.2-14: Metal flue cover at the center of the fireplace infill in Room 201.

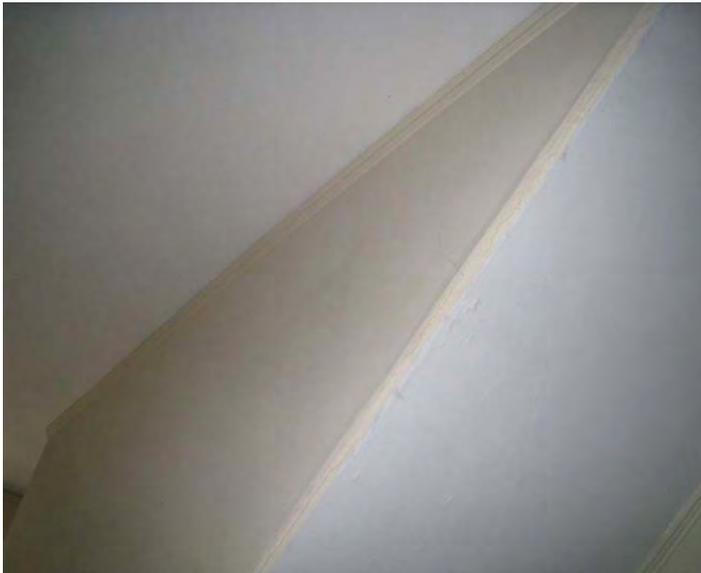
Photo 2.2-22: Cracking at plaster at edge of attic stair enclosure wall.

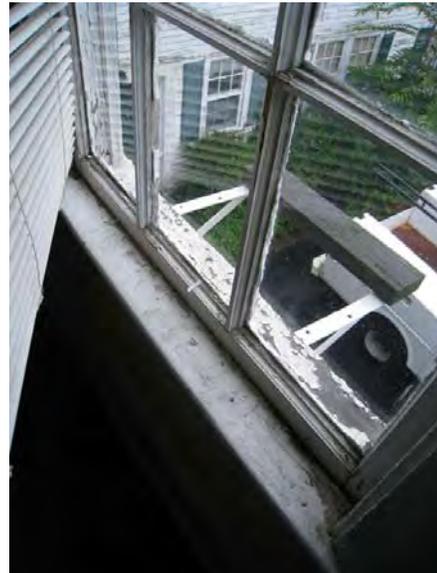
Photo 2.2-23: Water damage at interior sill, Room 204.

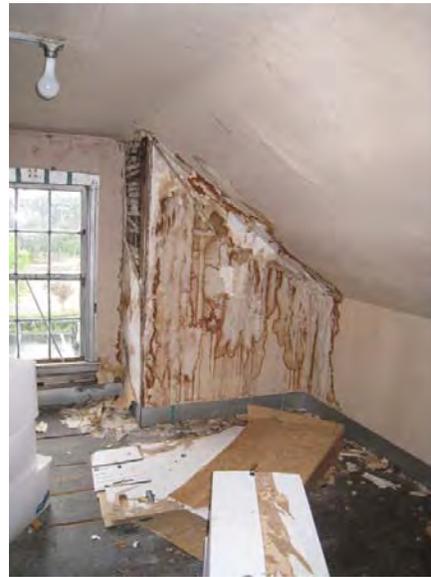
Photo 2.2-26: Water damage at chimney enclosure at east wall.

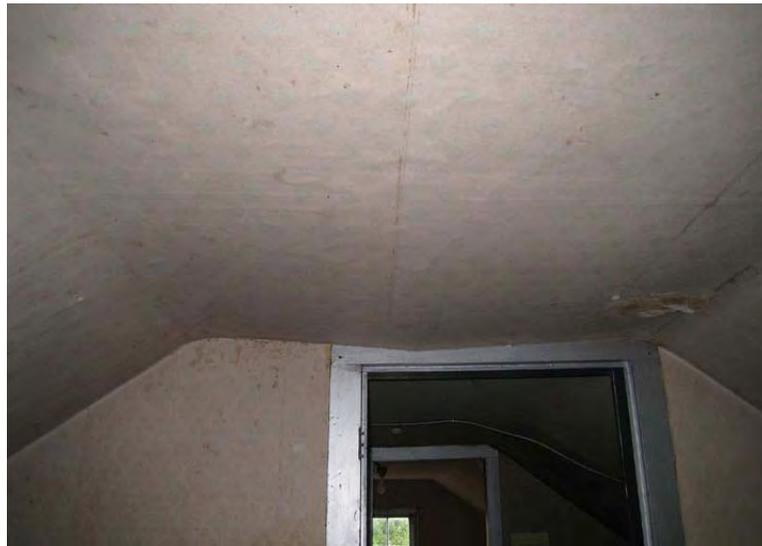
Photo 2.2-27: Bulge in ceiling at west side of Room 301.

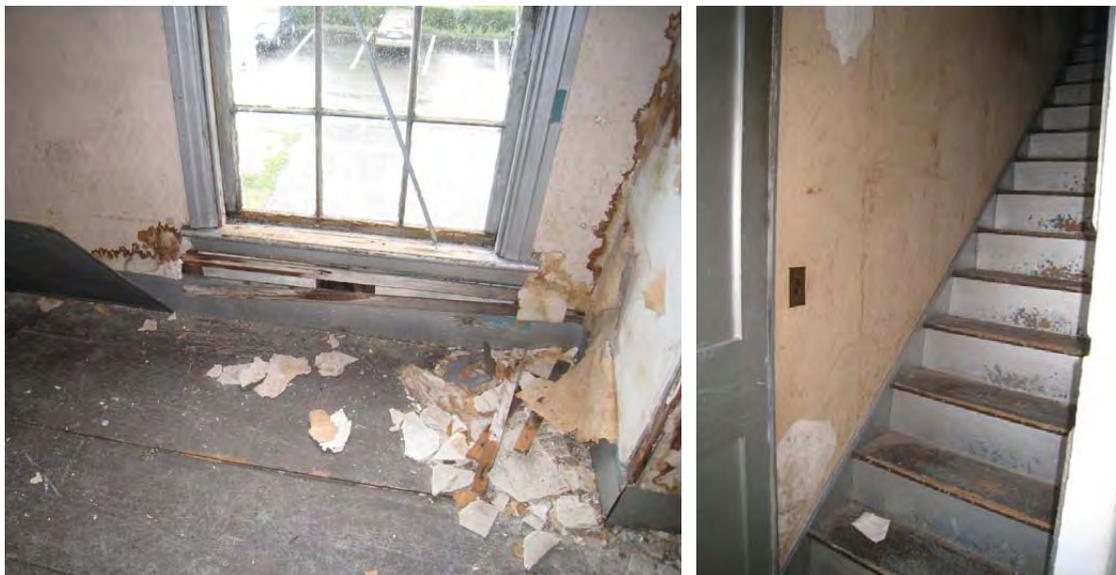
Photo 2.2-28: Water damage at stool and wall below west window.

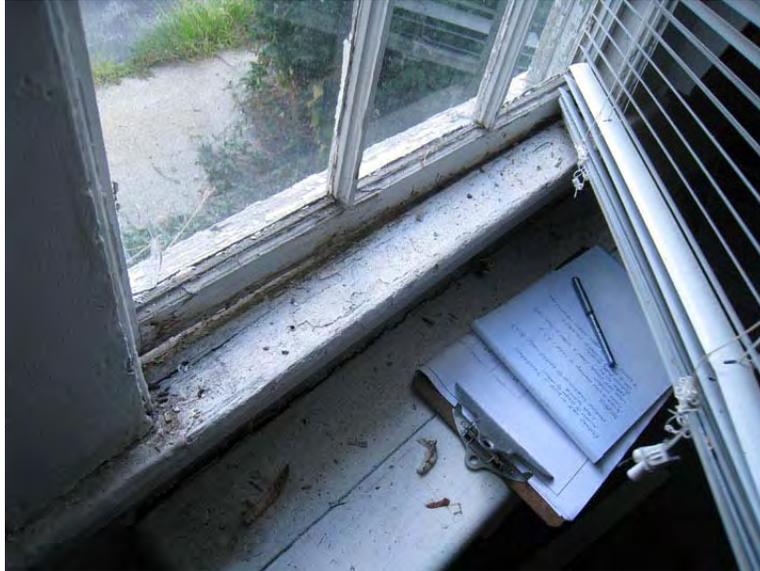
Photo 2.2-37: Water damage at north window sill and bottom rail.

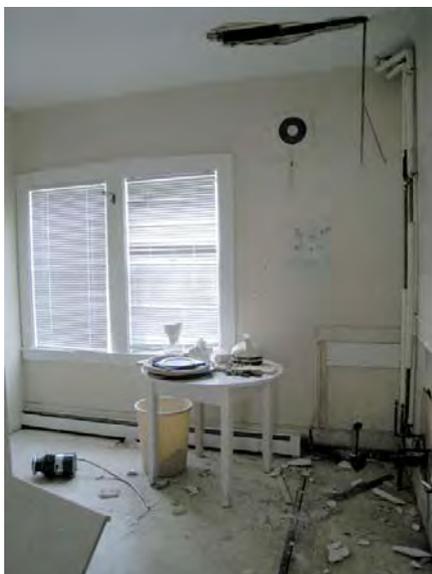
Photo 2.2-58: Overall view of Room 106. Note damaged ceiling and double window opening.

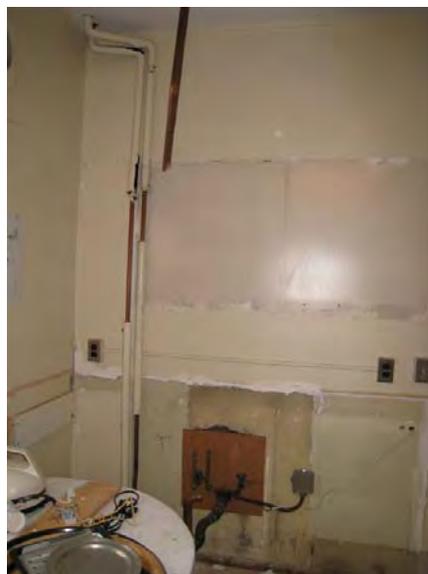
Photo 2.2-59: Area of damaged plaster at removed sink.

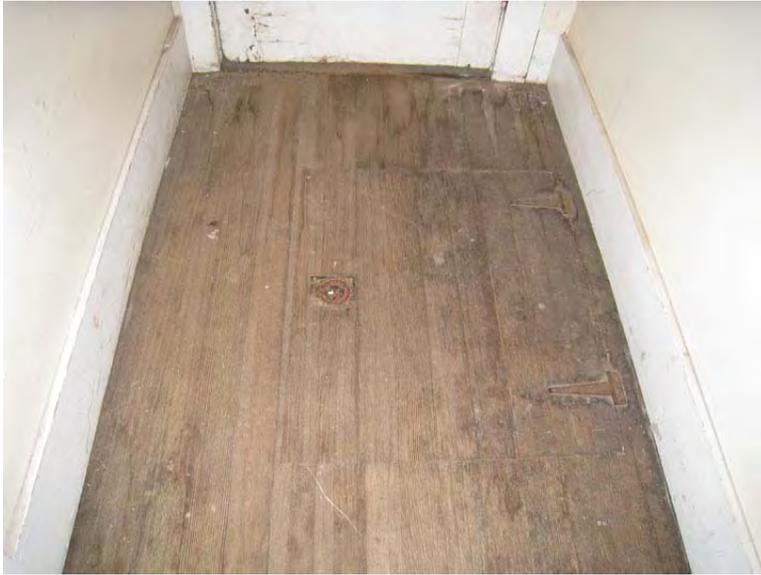
Photo 2.2-63: Hatch at floor in Room 111. Note water damage at floor near exit door.

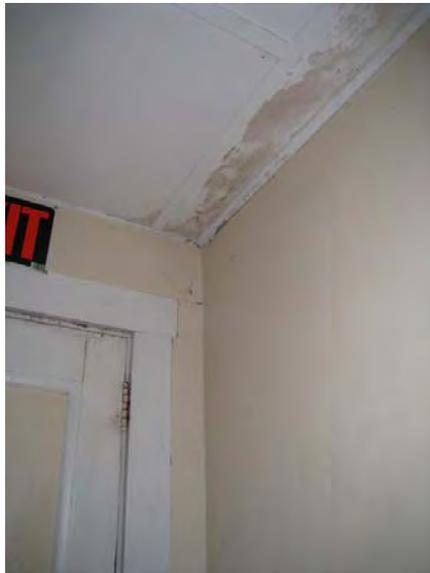
Photo 2.2-65: Water damage at northeast corner of ceiling, Room 111.

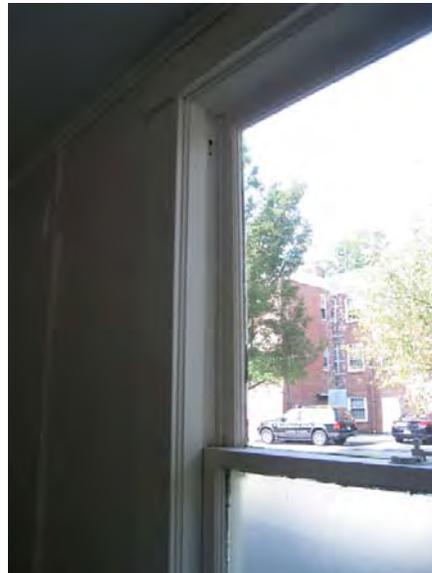
Photo 2.2-66: West wall window of Room 112. Note frosted glass pane below and missing ropes at window jamb.

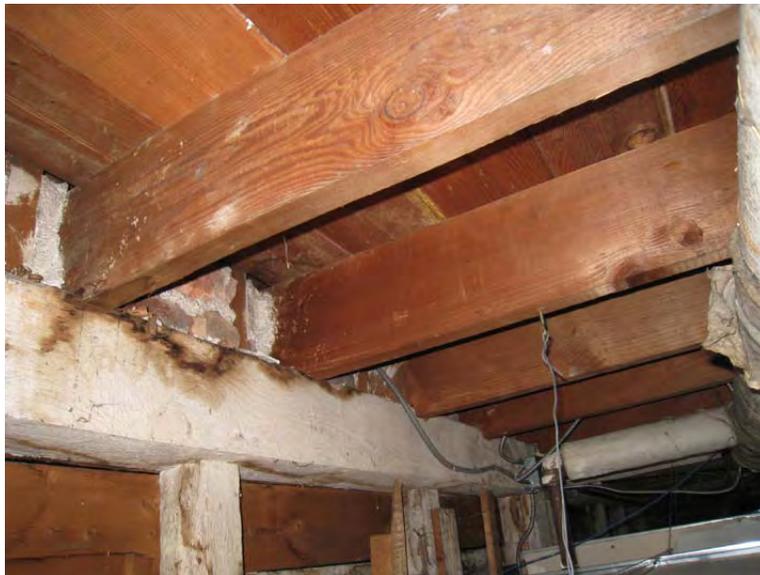
Photo 2.2-79: Brick installed at top of first floor ell structure. Note water damage at top of header post.

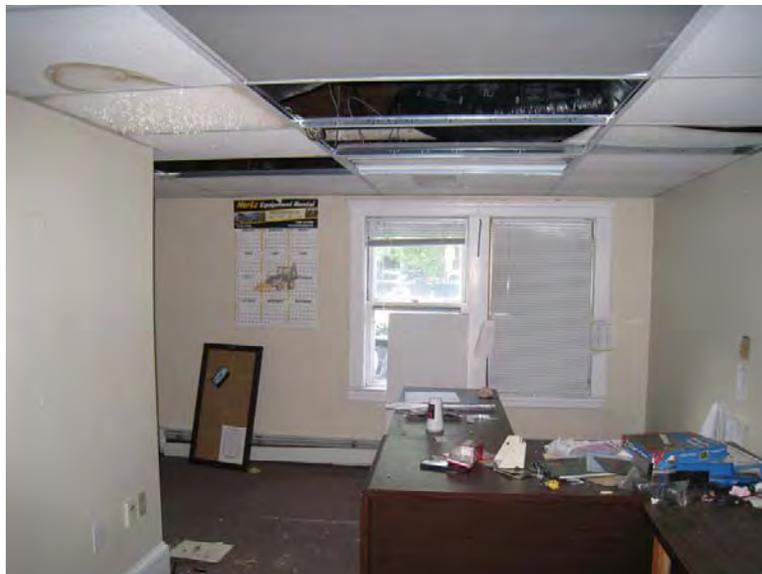
Photo 2.2-83: Overall view of Room 219. Note water damage at ceiling at west side of room.
