RE: First Parish in Lexington: Historic Structures Assessment

Project Title: First Parish Lexington, Exterior Preservation and Structural Priorities

Project Title: First Parish in Lexington Meetinghouse, Exterior Preservation & Structural Repairs

Existing Conditions

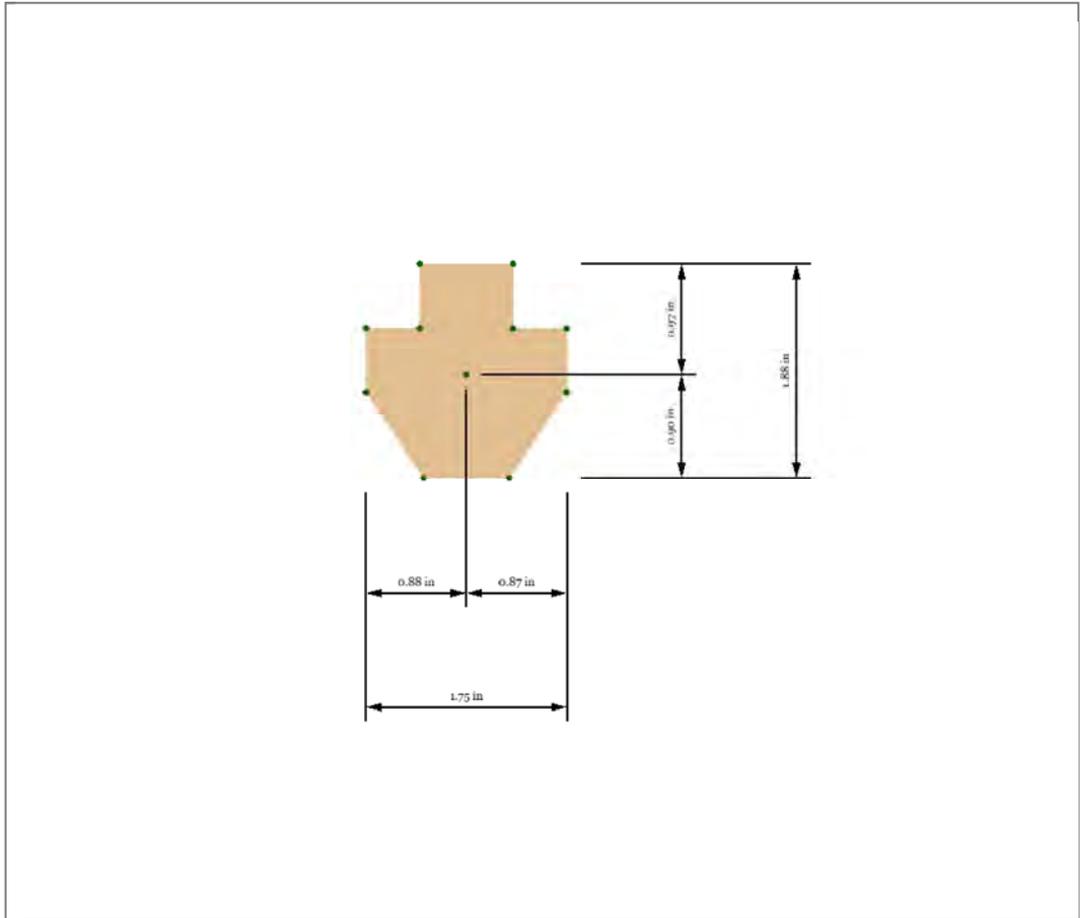
A structural analysis of the historic window confirms that the distinct off-set grid of the muntins lacks the structural rigidity of a conventionally arranged grid of window muntins. As a result the twelve and a half foot tall by four and a half foot wide windows are subject to high stresses and may be susceptible to failure caused by wind loads. While no failures have been recorded, one hundred seventy years of aging have increased the potential for pressure and weather to adversely affect the sash.
