Historic Structure Report  
**The Hammond A. Hosmer House**  
Lexington, Massachusetts  
BH+A Project No. 2991.00

Prepared by: Bargmann Hendrie + Archetype, Inc.  
300 A Street  
Boston, MA 02210  
617-350-0450

Prepared for: Town of Lexington  
Department of Public Facilities

November 30, 2010

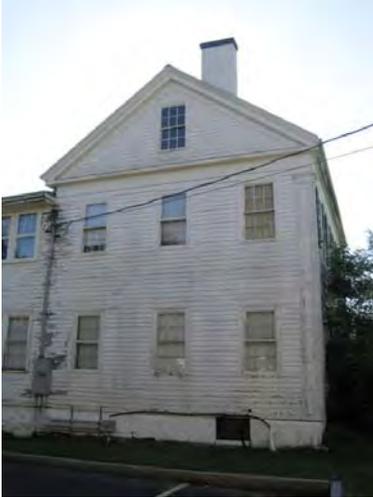
2.1-1: Stone blocks above stone rubble foundation at main block. Note transition to entirely stone rubble foundation wall at change in roofline (start of north ell).

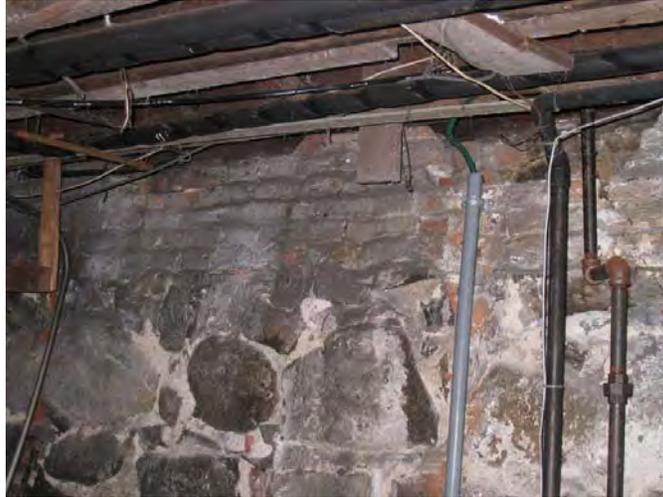
2.1-2: View of interior side of foundation wall showing brick backup above stone rubble foundation at south elevation of main block.

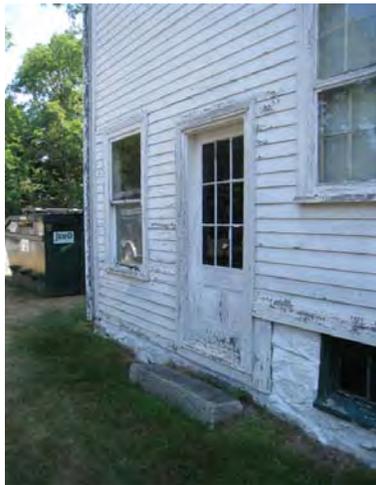
2.1-3: Stone rubble foundation wall at west elevation of north ell. Note step in foundation wall at the where Barnes addition begins.

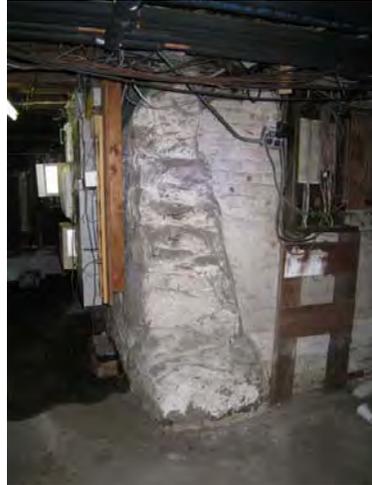
2.1-4: Exposed cross section of the main block foundation wall at the basement interior at the junction with the north ell.

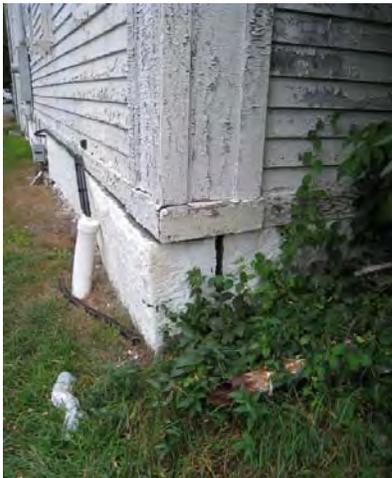
The foundation of the main block and north ell are in fair condition overall. A description of structural conditions found is located in the *Structural* section of this report and consists of crumbling stone at the west side of the north ell and a shifted granite block at the southwest corner of the main block (Photo 2.1-5). There is also a crack in the foundation wall at the east elevation between the east wall of the north ell and the south wall of the east ell (Photo 2.1-6). The above-grade portions of the foundation have been painted. The paint finish is in good condition except at the brick portion at the south side of the main block foundation where there is peeling paint (Photo 2.1-7). There are also several spalled bricks across this elevation.

Photo 2.1-5: Shifted granite block at southwest corner of main block foundation.

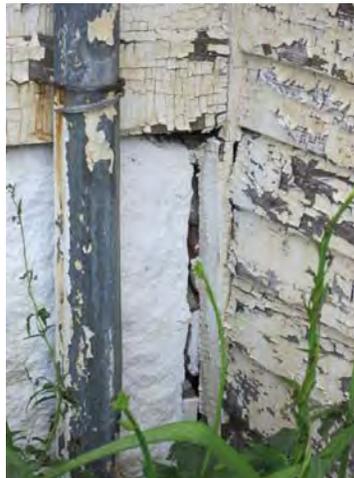
Photo 2.1-6: Crack at foundation between east wall of north ell and east ell.

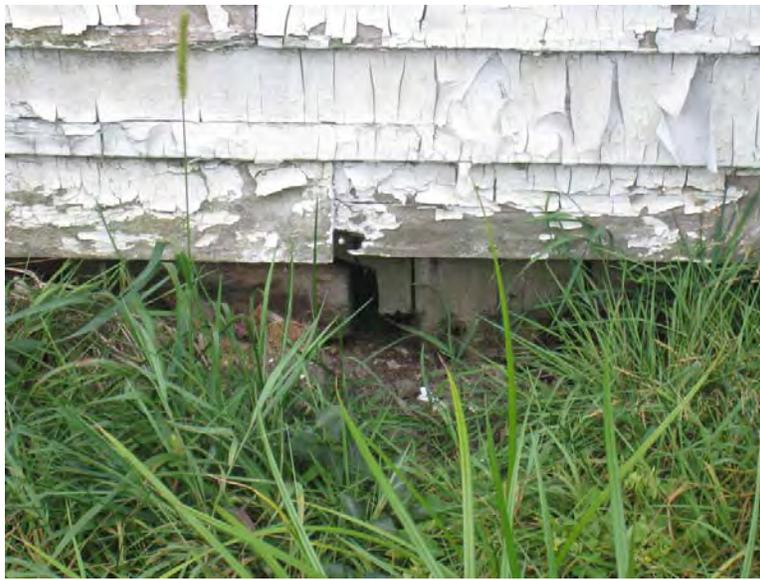
As noted in the description section above, very little of the east ell and barn foundations are visible from the exterior due to the grade level of the surrounding site. In many locations the wall cladding of these buildings rests directly against the earth, which is causing the wood siding to rot (Photo 2.1-10). Several holes can be seen at grade level along the north elevation of the east ell and barn, most likely due to rodents. There is a large hole near the center of the north elevation of the barn where the siding has rotted away and the end of one of the timber sills supporting the structure is exposed (Photo 2.1-11). The sill end appears to be extensively rotted. Dense vegetation and the presence of a large wasp nest prevented careful investigation of any exposed portions of the south elevation of the east ell foundation.

Photo 2.1-11: Hole, rotted siding, and exposed timber sill at north wall of barn.

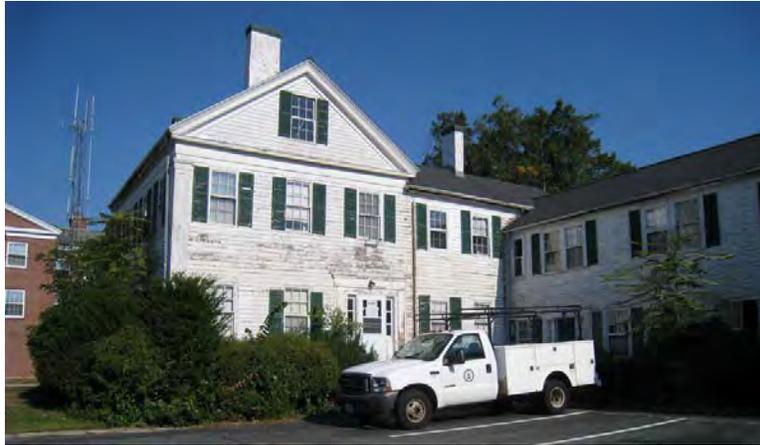
The clapboard siding is in fair condition overall, despite the deteriorated paint and some specific areas of significant damage. There is widespread failure of the exterior paint at the siding at all locations, and localized areas of wood rot particularly at those areas subject to roof run-off from failed gutters and areas located near grade. The worst of these areas of rot is at the north elevation at the junction between the Barnes addition and the east ell where a failed gutter at the northeast corner of the addition roof has created an area of water damage and staining down the entire wall (Photo 2.1-14). Other areas of deteriorated clapboards include: below the soffit at the southwest side of the Barnes addition on the west elevation (Photo 2.1-15); the junction between the east ell wall and barn roof at the south elevation where several clapboards are detached (Photo 2.1-16); grade level at the northeast corner and east elevation of the barn (Photos 2.1-17 and 2.1-18); grade level at the center of the north barn wall; the junction between the east wall of the north ell and the east ell roof at the south elevation (Photo 2.1-19); the junction between the wall of the small "pop-out" extension at the second floor of the east ell at the north elevation where it abuts the second floor east ell roof, both sides (Photo 2.1-20); and the south wall of the east ell, adjacent to the entrance door (Photo 2.1-21).

Photo 2.1-12: East elevation of main block and north ell, south elevation of east ell.

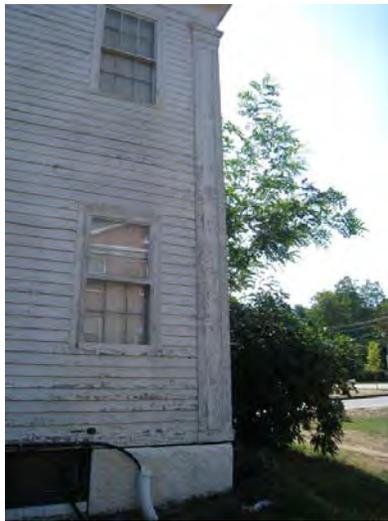
Photo 2.1-13: Corner pilaster at west elevation of main block.

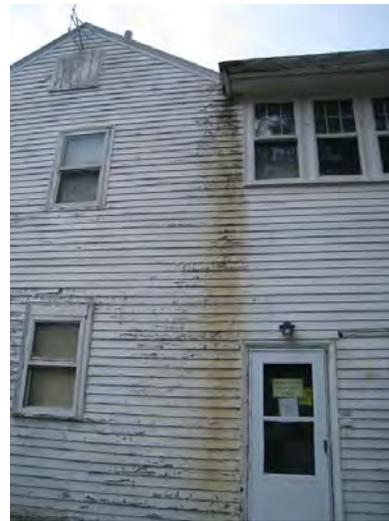
Photo 2.1-14: Area of staining and wood rot at junction between Barnes addition and east ell at north elevation.

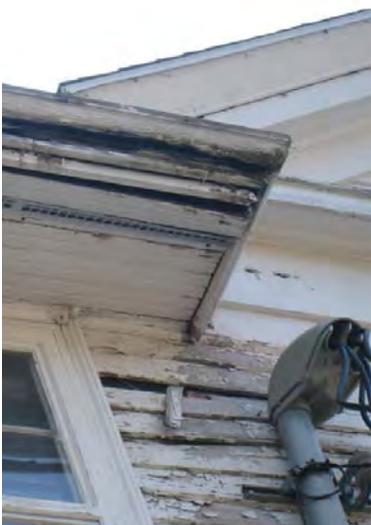
Photo 2.1-15: Deteriorated clapboards at the southwest corner of the Barnes addition, west elevation.

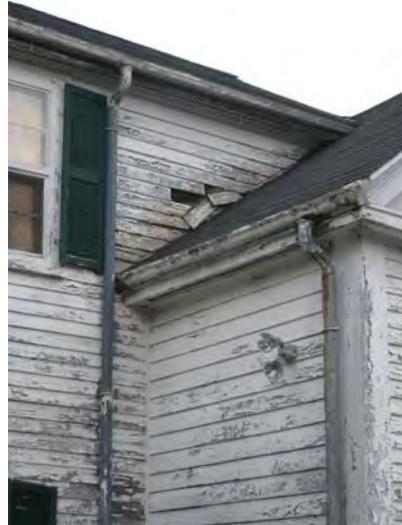
Photo 2.1-16: Deteriorated clapboards at the junction between the east ell wall and barn roof, south elevation.

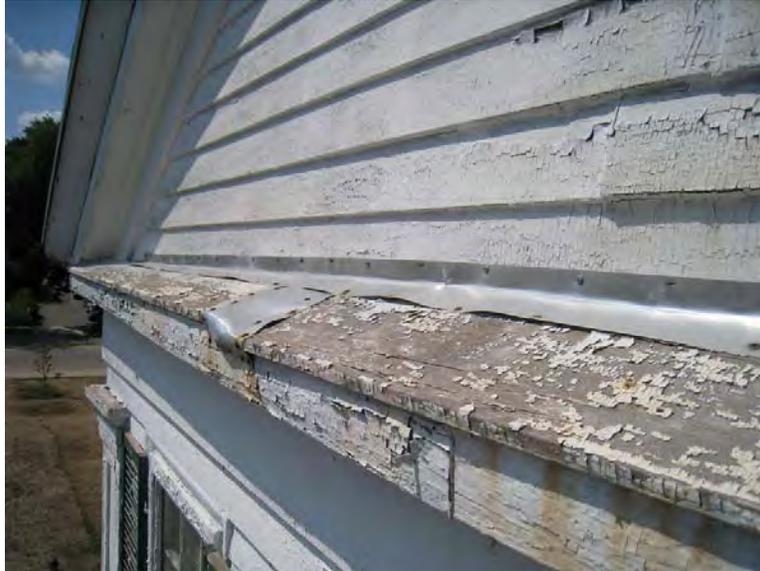
Photo 2.1-25: Metal flashing at junction of cornice element and building wall, main block.

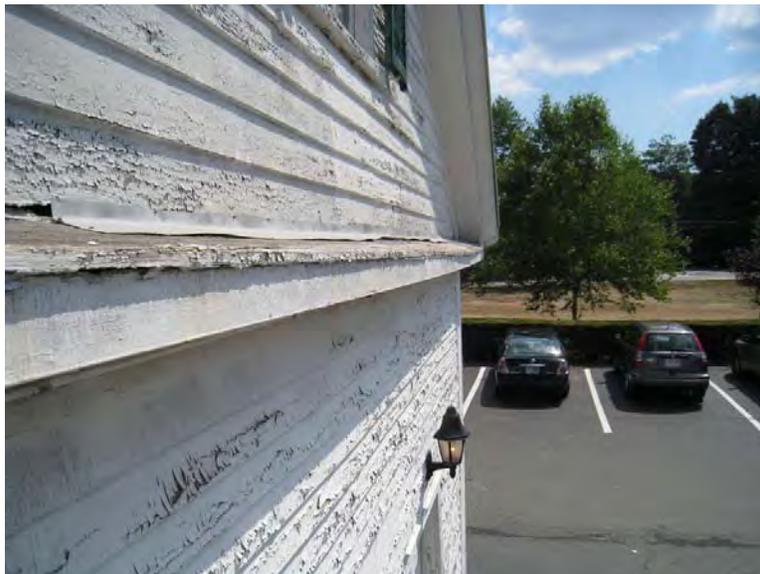
Photo 2.1-26: Metal flashing at garage flashing element.

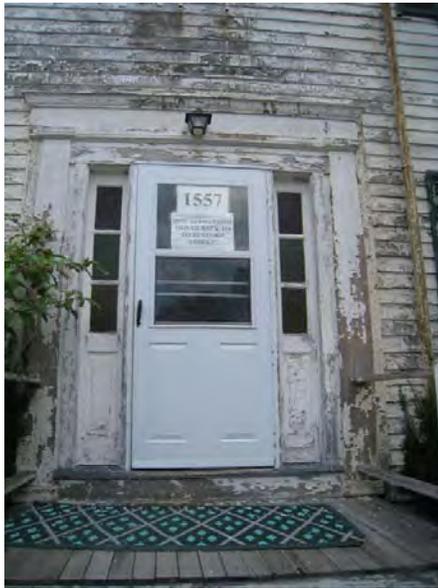
The entrance door into the main block is a six panel wood door with vision glass installed at the center two panels and sidelights at either side of the door. An unsightly aluminum storm door has been installed at the exterior side of the door (Photo 2.1-27). The wood door and aluminum storm door are in good condition. There are three glazed lights at each sidelight, vertically stacked, and a wood panel fills in the bottom third of each opening. The sidelights are in fair condition as the putty around the lights and the exterior paint has failed. The door and sidelights are framed with pilasters and an entablature which are in fair condition with paint delamination throughout. There is some evidence of wood rot at the top of the pilaster caps at either side of the opening. The wood sill below the door is completely devoid of paint and is worn, with evidence of wood rot at the exterior edge. The door is located 3'-8" above grade level and is accessed via a non-historic wood stair and landing. The stair and landing elements are in poor condition, with checked and rotten boards and a north railing that is leaning away from the stair (Photo 2.1-28). Neither the stairs nor railings comply with modern codes.

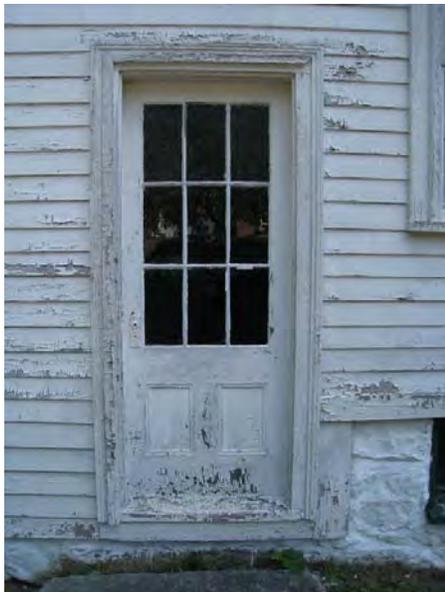
The door into the Barnes addition at the west elevation is a wood door with a divided light window installed at the top two-thirds of the door and two wood panels below (Photo 2.1-29). Door trim consists of 5" wide casing with a molded profile and a wood sill. The top of the sill is 1'-2" above grade level. The door is in fair condition with some wood rot at the lower rail and failed paint throughout. The glazing putty at the lights has also failed. The exterior door handle is missing. The door casing and door sill are also in fair condition, with extensive paint loss.

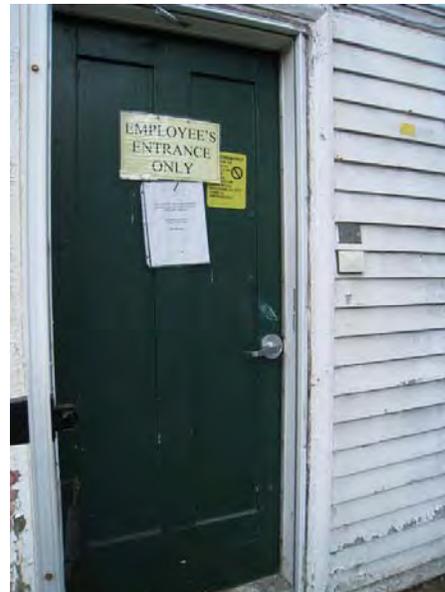
The door into the Barnes addition at the north elevation is a two-panel wood door retrofitted with modern lever hardware (Photo 2.1-30). This door is in fair to poor condition, with some wood rot at the top and bottom rail, particularly on the interior side. The west panel is displaced at the interior side. An aluminum storm door has been installed at the exterior of the door opening which is in good condition. Door trim consists of a 5" casing with a plainer molded profile than the west door. The casing is in fair condition. Sealant residue is present at the casing at the perimeter of the storm door frame. The door has a wood sill that is in poor condition.

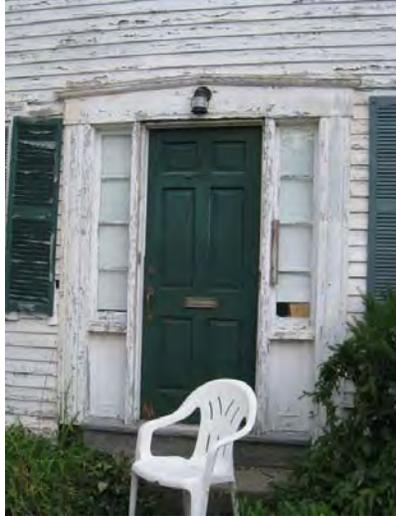
The entrance door into the east ell at the south elevation is a six panel wood door with sidelights at either side of the door (Photo 2.1-31). The door opening is 2'-8" wide and 6'-6" high. The door is in fair condition, with rot at the bottom rail and paint failure. Hardware consists of a thumb latch pull and a deadbolt and a mail slot with hinged cover at the center of the door. There is wood rot at the base of the door frame on both sides of the door. The sidelights have four glazed lights each, stacked vertically, and wood panels below. Between the glazing and wood panels is a thick wood rail. The sidelights are in fair to poor condition with failed glazing putty and failed paint throughout. Both the door and the sidelights appear to be wracked within their openings, particularly the sidelight at the east side of the door. A board has been nailed to the door frame at the east sidelight. The door and sidelights are framed with pilasters and a pedimented entablature which are in fair condition with widespread paint loss. A piece of the west pilaster is missing from the base of opening. The door is 1'-3" above grade and is accessed by one concrete step and one wood step that also serves as the door sill. The wood step/sill is in poor condition. The steps do not meet current codes.

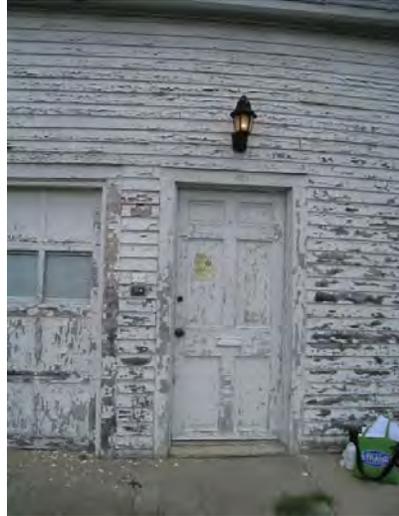
The entrance door into the barn at the south elevation is a six panel wood door of similar construction to the east ell entrance door with flat 4 1/2" casing and a stone sill (Photo 2.1-32). The door is in fair condition with paint loss throughout. Hardware consists of a knob, deadbolt, and mail slot with hinged cover at the center of the door. The door casing is in poor condition, with rot at the base of the casing on both sides of the door, which is directly in contact with the ground. There is also checking and splitting at the top of west jamb where it meets the head casing. The stone sill is in fair condition, with gouges at the projecting exterior edge.

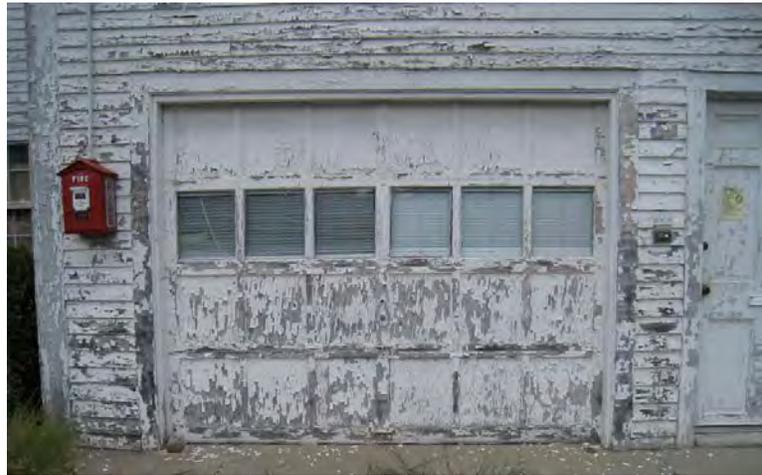
The large garage door at the south elevation is a 24 panel rolling door with glazing installed in the second row of panels (Photo 2.1-33). This door is no longer operational, and has been closed in on the interior side with wall framing and drywall except at the window openings. The door is in poor condition with extensive paint loss. Rot is present along the bottom rail, which is directly in contact with the ground. There is a badly rusted pull handle installed at the bottom rail of the door. Door casing consists of 4 1/2" wide flat boards that are also in poor condition.

Photo 2.1-33: Large garage door at south elevation.

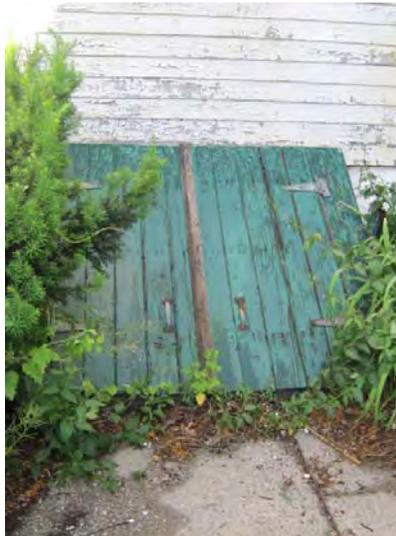
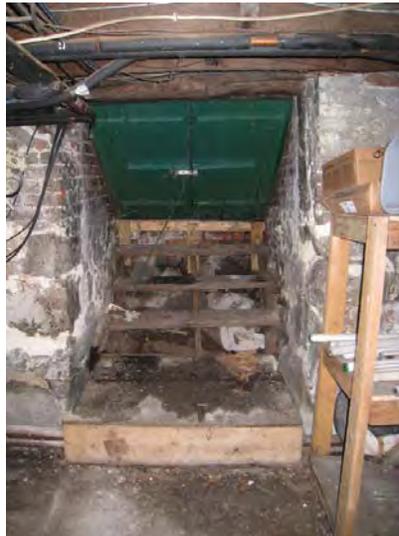
The door at the basement bulkhead consists of two leafs made of individual boards braced on wood boards at the interior side of the door leafs (Photo 2.1-34 and Photo 2.1-35). Hardware consists of strap hinges, a pull mounted to each leaf and a surface mounted deadbolt lock at the interior side of the door. The door leafs extend from the bottom to top of the opening, and have wide wood rails at the sides where the hinges are mounted. The door is in poor condition, with areas of rot at the bottom edge of each individual board and at the intersection between boards. The handle hardware is rusted. This door is a significant source of water infiltration into the basement.

Photo 2.1-34: Basement hatch at east elevation  
Photo 2.1-35: Interior view of basement hatch showing water infiltration at basement.

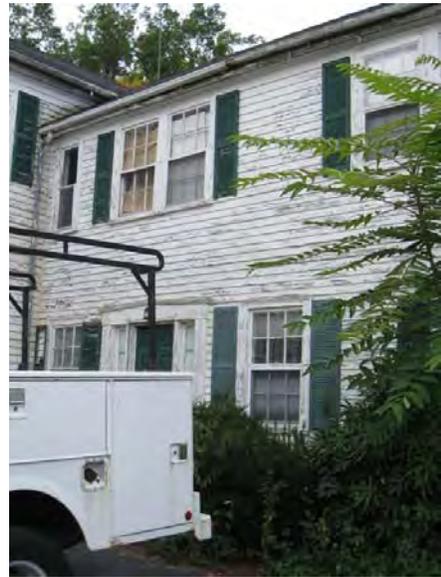
The windows at the Hammond A. Hosmer House are in fair condition overall. Glazing putty and exterior paint has failed or is failing at all windows, and many are in need of restoration to return them to an operable state. There are a few windows with broken individual panes of glass, and one window at the west side of the first floor of the south elevation where a pane has fallen out due to complete failure of the glazing putty. In general, the windows that still have their exterior storms are in better condition than those without. All of the shutters on the building are in poor condition with extensive paint loss and rotted or missing elements. The window at the east side of the east ell entrance on the south elevation has replacement shutters that do not match the shutters found at the rest of the south and east windows (Photo 2.1-49). Interior conditions at the windows will be discussed in the interior section of this report.

Photo 2.1-48: Window at east wall of barn.  
Photo 2.1-49: Replacement shutter at first floor window, south elevation of east ell.

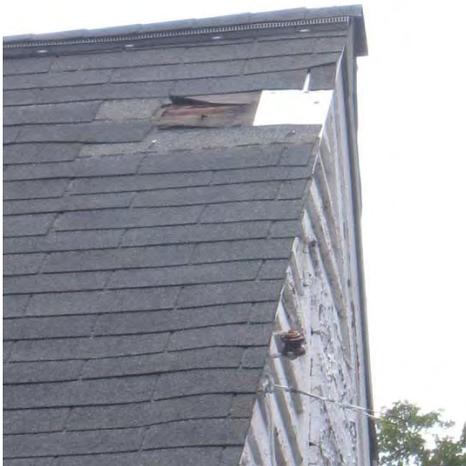
The asphalt roofing are in good condition overall. Vent flashings are galvanized metal and appear to be water-tight. At the northeast corner of the Barnes addition there is an area where it appears that some of the roof sheathing has been cut back. A piece of EPDM roofing has been adhered to the wood sheathing at this location (Photo 2.1-56). The EPDM patch runs below the asphalt shingles of the adjacent roof, but hangs loose at the building wall and at its outer edges. There is a hole in the wood siding where the EPDM meets the building wall, and the way that the EPDM is folded appears to be funneling water into the opening in the siding (Photo 2.1-57). There is significant deterioration at the building wall and adjacent wood soffit at this location (Photo 2.1-58). There is a missing asphalt shingle tab at the northeast side of the barn roof along the gable rake. Bare exposed sheathing is visible at this location and there is a corresponding leak at the interior of the barn attic (Photo 2.1-59).

Photo 2.1-59: Missing shingle tab at barn roof. Note exposed (deteriorated) roof sheathing.

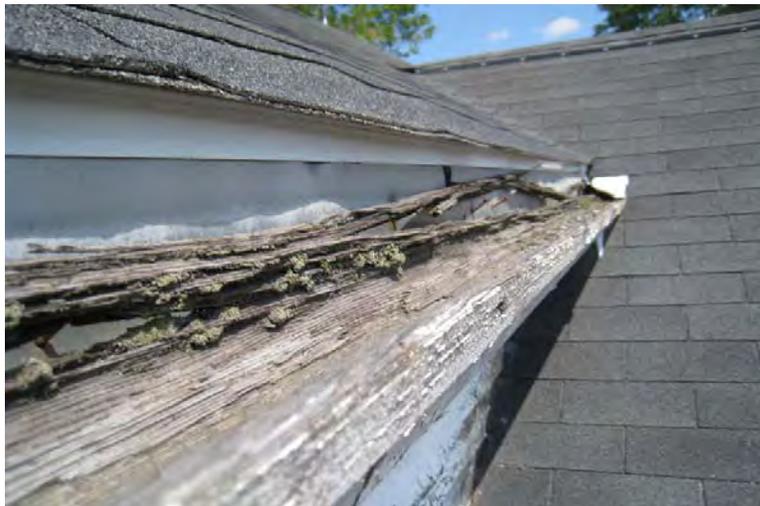
The condition of the soffits and gutters is poor at all areas of the building. All of the wood gutters are unlined and have failed, with badly rotted wood and holes visible at all areas. Most of the galvanized metal leaders are either missing or are no longer attached to the gutters. The failed gutters have caused severe deterioration at the building soffits and fascia boards throughout the structure. In many locations the rotted gutter can no longer hold the gutter fasteners and the gutters are pulling away from the building wall (Photo 2.1-61). The wood gutter at the north elevation of the east ell second floor has completely detached and fallen off the building. Holes were noted in the rotted fascia boards along the south elevation of the main block and east ell that are allowing animals entrance into building attic (Photo 2.1-62). In addition to the hole in the fascia at the main block there is an area of lifted roofing that looks like it has been created by animal activity (Photo 2.1-63).

Photo 2.1-61: Gutter pulling away from building wall at east elevation of north ell.

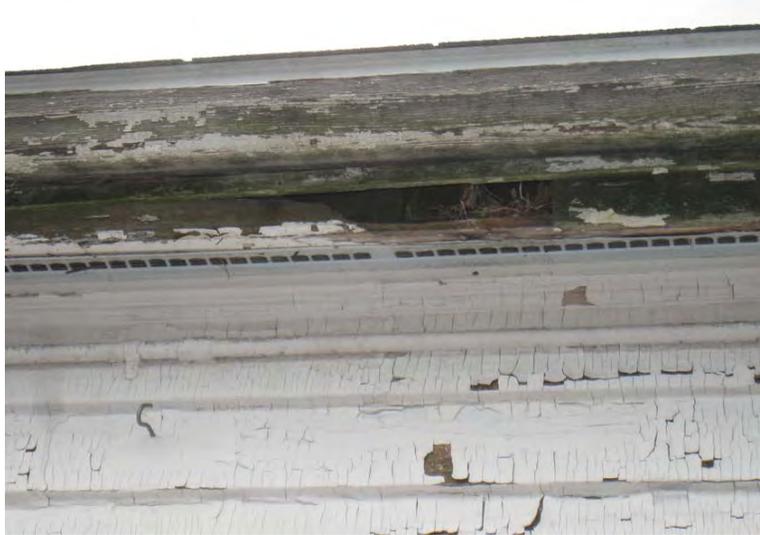
Photo 2.1-62: Hole in fascia board, north elevation of main block.

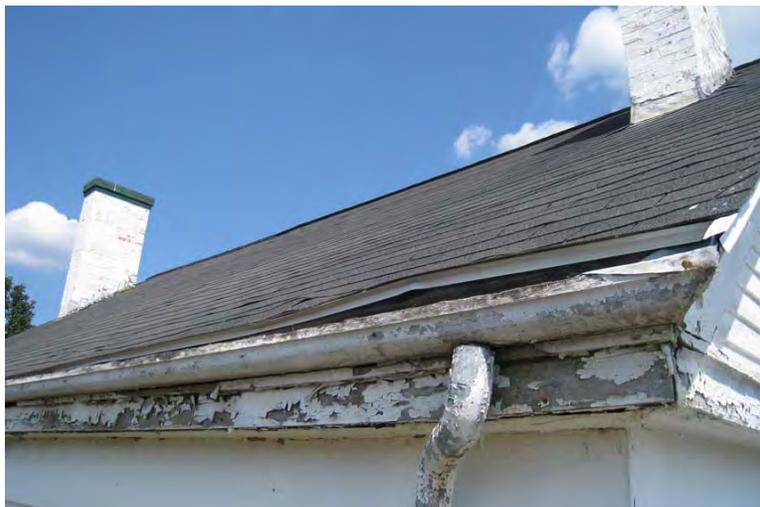
Photo 2.1-63: Lifted area of roofing, main block south elevation.

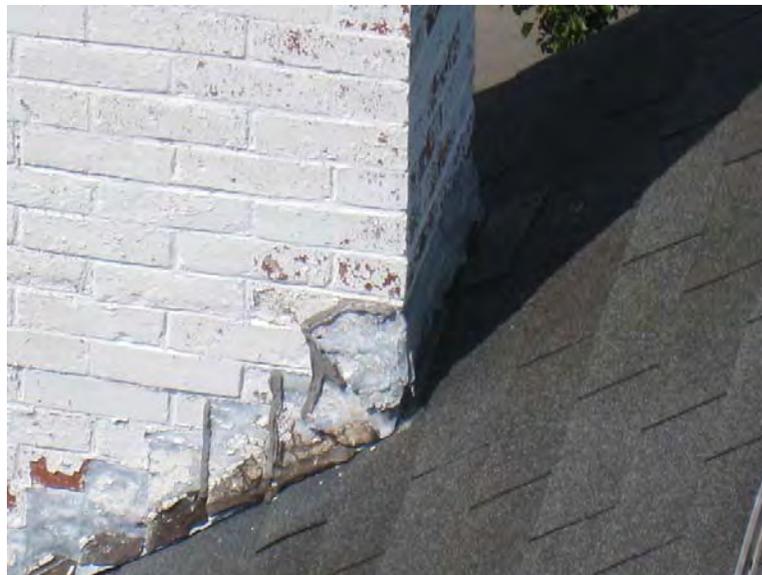
The chimneys are in good condition overall with some loss of paint at the exterior surface of the brick. The counterflashing appears sound although some sealant has been applied at the upper edge of the counterflashing on the east main block chimney. The flashing appears to have once been painted, but most of the paint is missing. There is severe water damage visible at the interior below the north and west chimneys, but this damage appears to predate the re-roofing as during a site visit on a rainy day the interior spaces remained dry. There is residue from previously-installed at the base of the counterflashing, presumably from attempted leak repairs prior to the installation of the new roof (Photo 2.1-66).

Photo 2.1-66: Lead coated copper counterflashing at east main block chimney. Note mastic residue at bottom edge of flashing.

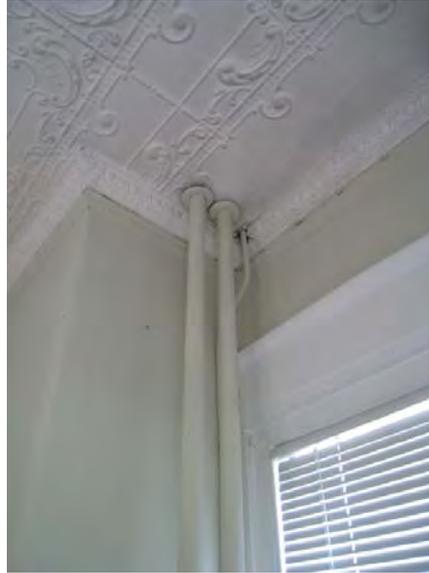
The painted pressed tin ceiling is in good condition. Two pipes penetrate the ceiling at the south side of the hearth (Photo 2.2-2).

Photo 2.2-1: Overall view of Room 101 showing fireplace and heater.  
Photo 2.2-2: Pipe penetration at painted tin ceiling, Room 101.

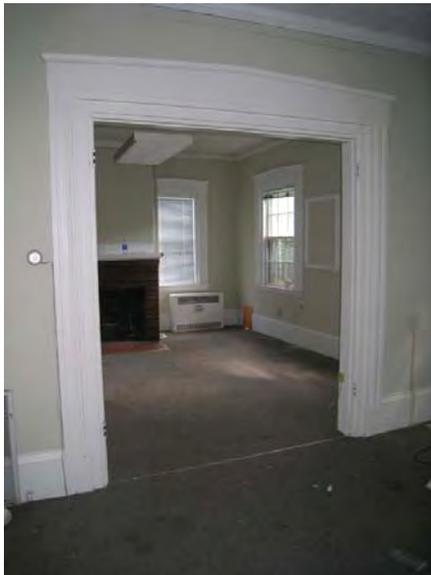
Photo 2.2-3: Door opening between Room 101 and Room 102. Note hinges at Room 102 side.  
Photo 2.2-4: Crack at back corner of firebox. Also note steel lintel at opening in firebox surround.

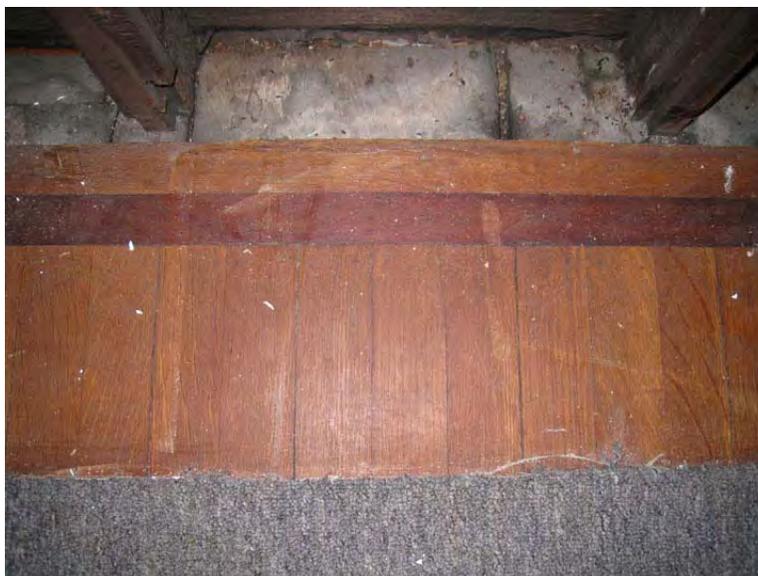
Photo 2.2-5: Exposed wood flooring at Room 102.

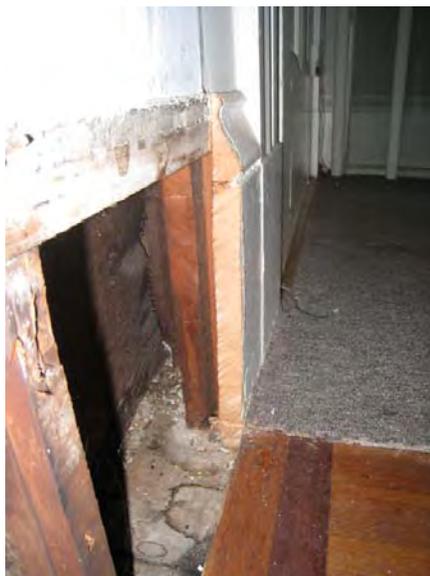
Photo 2.2-6: Exposed wall construction and baseboard profile, Room 102.

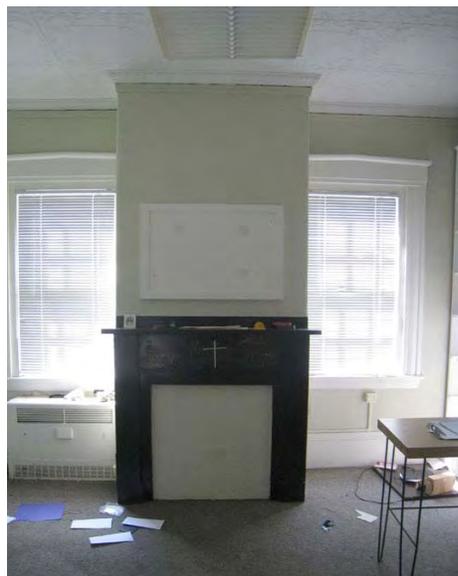
Photo 2.2-7: Infill wall at fireplace opening, Room 102.

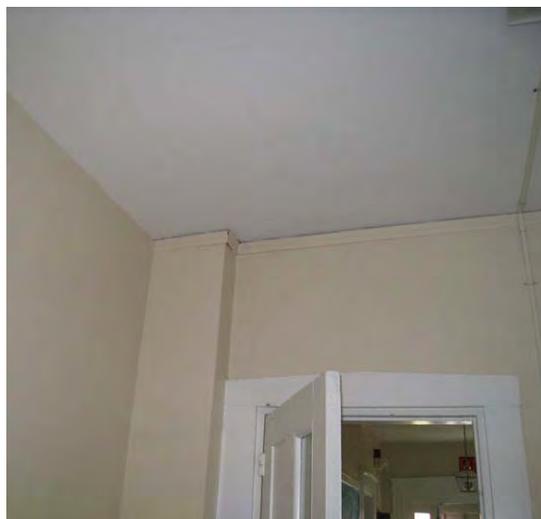
The south, east and west walls of Room 103 are smooth painted plaster in fair condition. The north wall is also painted plaster, but of more modern construction, with no trim (Photo 2.2-8). This wall is also in fair condition. There are some holes and marks on the wall from where wall mounted shelving and a countertop have been removed. The ceiling is painted plaster which is in fair condition with some cracking across the surface.

Photo 2.2-8: North and east walls at Room 103. Note lack of trim at north wall.  
Photo 2.2-9: Door opening between Room 103 and Room 104 with vision glazing.

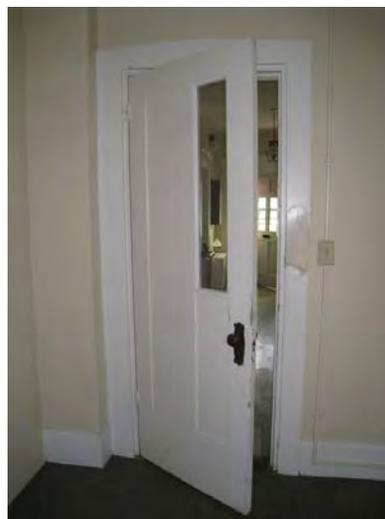
The door opening between Room 103 and Room 104 is 2'-5" wide and 6'-9" wide. The door in the opening is a two-panel wood door. The upper half of one of the panels has been removed and replaced with vision glazing (Photo 2.2-9). The door has a brass knob and escutcheon with keyhole. There is a low (approximately 1/8" high) wood threshold at the bottom of the door opening.

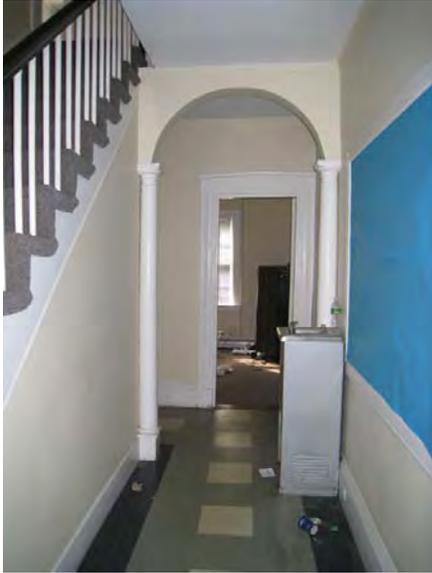
The ceiling is painted plaster, in fair condition. There is some cracking at the edges of the stair opening. The arched opening and wood columns between the end of the stairs and the north wall is in good condition (Photo 2.2-10).

Photo 2.2-10: Arched opening adjacent to stairway in Room 104.

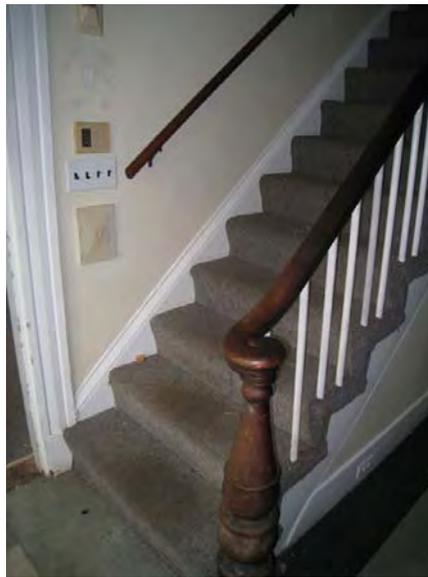
The original wood rail at the north side of the stair is 3" wide (Photo 2.2-12). . The top of the rail is located 1'-10" above the tread nosings. The rail is supported on 1" diameter bannister posts spaced 4 1/2" on center. A modern round wood rail has been installed at the south side of the stair. This rail is 1-1/2" in diameter and is located 2'-5" above the tread nosings. This rail is fastened to the wall with brackets and is wobbly.

Photo 2.2-12: Stair rails at Room 104.

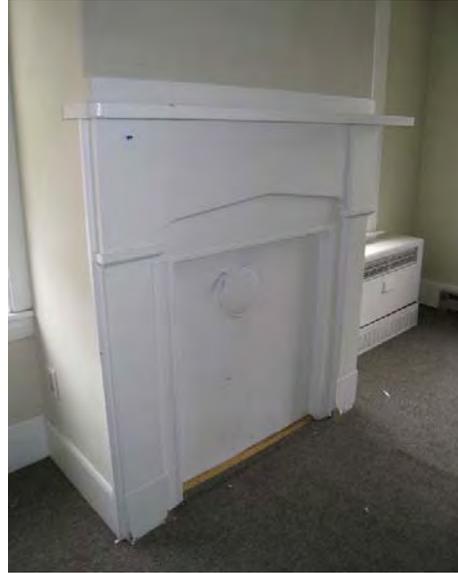
The fireplace at the east wall has been infilled with a plaster wall behind the fireplace surround. At the center of the plaster is a metal flue cover that has been painted over (Photo 2.2-14). The plaster infill wall is cracked at the perimeter of the flue cover. The fireplace surround is painted wood and is in good condition although there are some areas of missing paint and scuff marks at the base of the surround. The hearth has been carpeted over.

Photo 2.2-13: Cracks in plaster wall at the back of the closet in Room 201  
Photo 2.2-14: Metal flue cover at the center of the fireplace infill in Room 201.

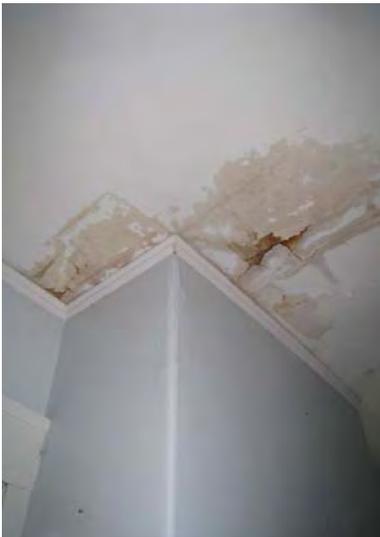
The painted plaster ceiling is in fair to poor condition. There is an area of water damage at the southwest corner of the room near the chimney (Photo 2.2-15). At a site visit on a rainy day this area was dry indicating that the source of the leak (likely the west chimney/roof intersection) has been fixed. There are areas of hairline cracking and peeling paint visible at the rest of the ceiling surface.

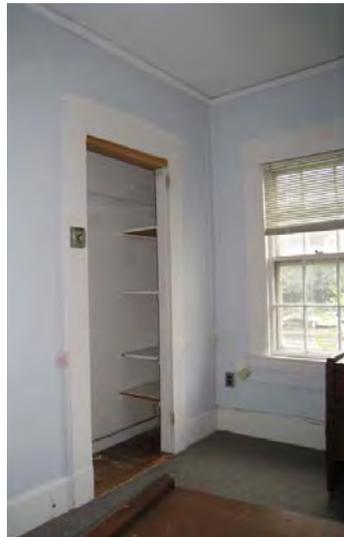
Photo 2.2-15: Water damage at ceiling in Room 202.  
Photo 2.2-16: Board nailed into head of wracked frame at closet door, Room 202.  
Photo 2.2-17: Doors between Room 202 and Room 203 (left) and Room 204 (right).

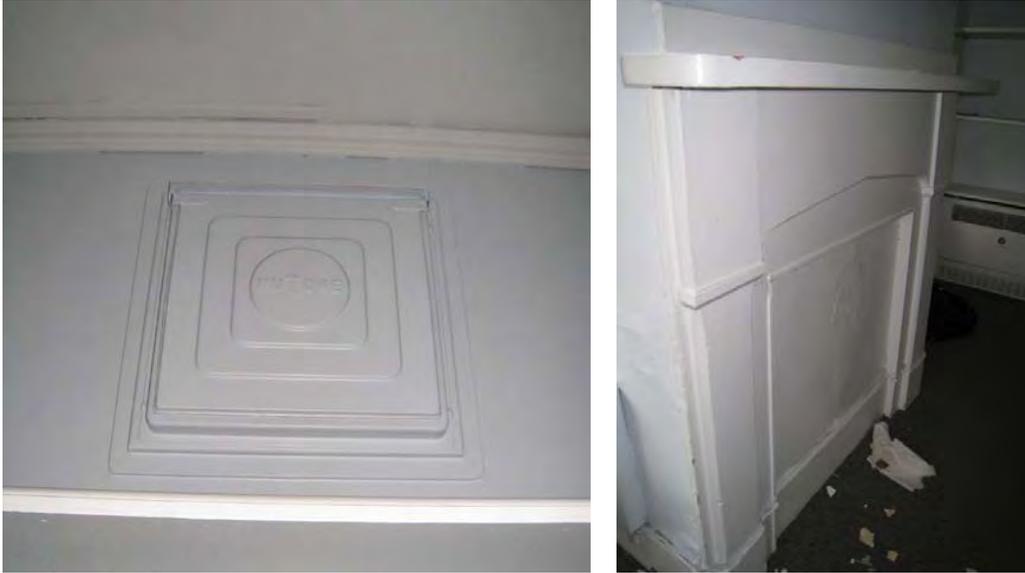
A radiator is located at the northwest corner of the north wall, built into the shelving unit at that wall. Lighting consists of two 4-lamp ceiling mounted fluorescent fixtures. There is a through-wall fan installed inside the north wall between Room 202 and Room 203. The fan blades are located in Room 203, and the metal cover that serves as the back of the fan is all that is visible within Room 202 (Photo 2.2-18).

The fireplace at the west wall has been infilled with a plaster wall. Unlike Room 101 there is no flue cover at the infill wall. However, there is a circular area of cracked plaster at the center of the wall at roughly the same location (Photo 2.2-19). The painted wood fireplace surround is the same as found in Room 201 and is in good condition.

Photo 2.2-18: Back of fan installed through north wall.  
Photo 2.2-19: Circular cracked area at fireplace infill wall.

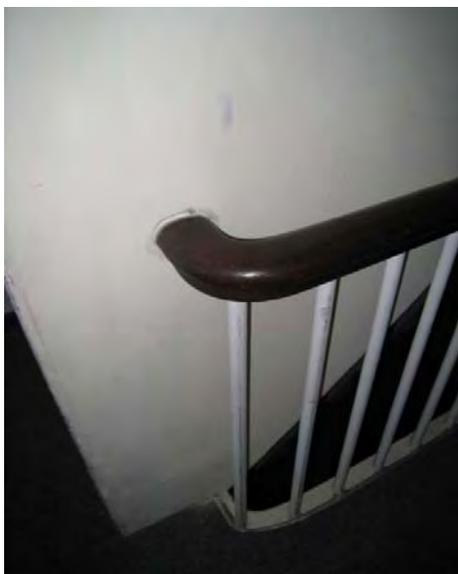
There is a wood guard rail at the north side of the stair opening. The rail is 2'-7 1/2" high and consists of a 3" high varnished top rail supported on 1" diameter painted wood posts spaced 5" apart. The stair rail is in good condition. The east end of the rail curves to meet the wall of the attic stair enclosure (Photo 2.2-24).

Photo 2.2-24: Guardrail at stair opening at Room 204.

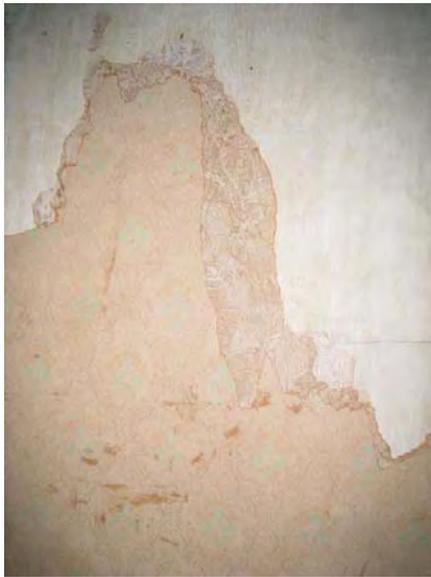
Photo 2.2-25: Layers of wallpaper at attic stair enclosure wall.

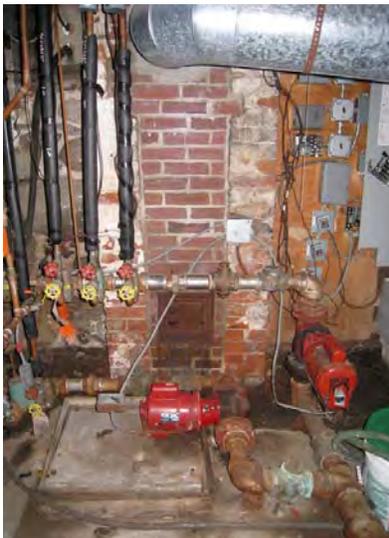
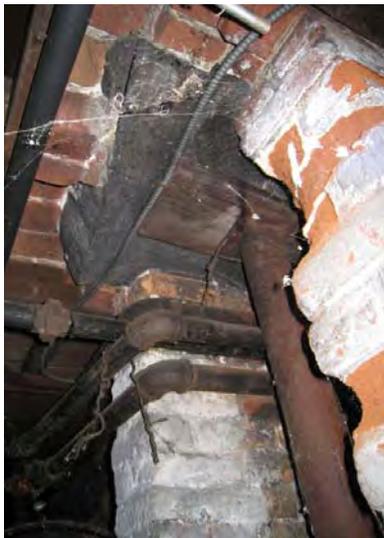
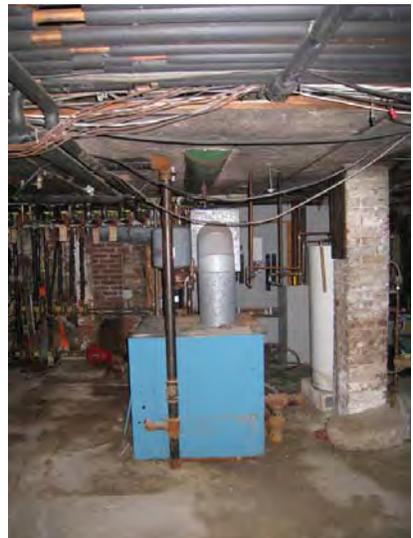
Photo 2.2-30: Brick chimney with newer brick infill at center.

Photo 2.2-31: Lally column supporting hearth of Room 101 fireplace above.

Photo 2.2-32: Area of plaster ceiling above boiler.

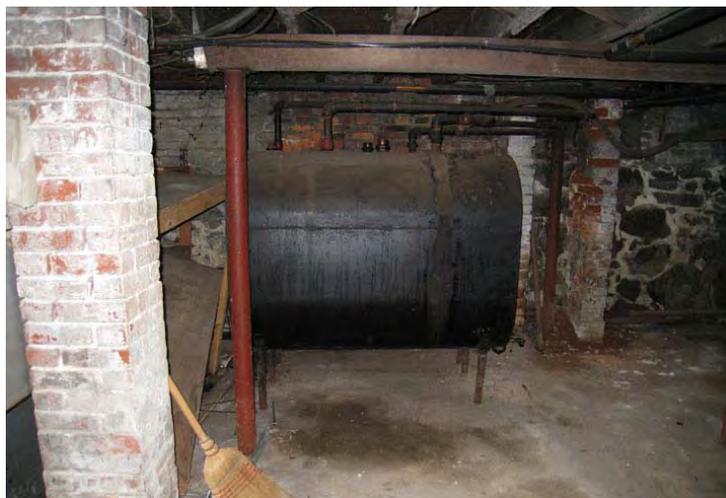
There is mechanical equipment throughout the basement. Large items consist of a boiler at the west side of the room (manufactured by Burnham) and an oil tank against the east wall of the room (Photo 2.2-34).

Photo 2.2-34: Oil tank at east side of Room B01.

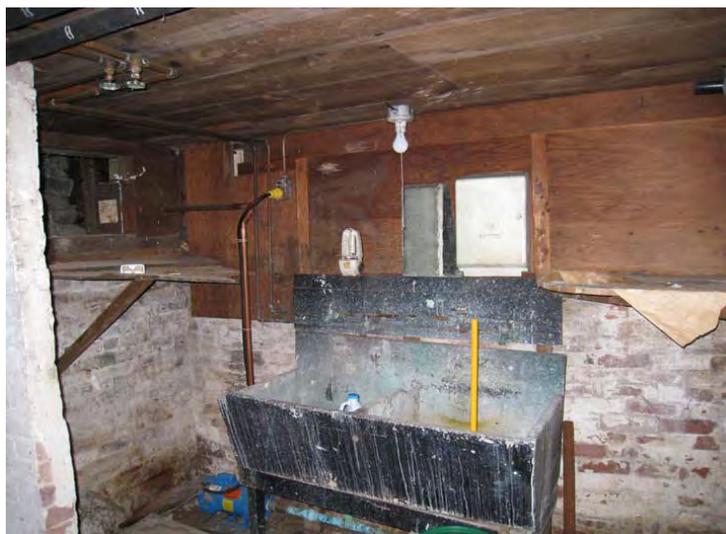
A soapstone sink is mounted to the north wall of the space (Photo 2.2-35). The sink is in fair condition although stained with paint.

Photo 2.2-35: Soapstone sink at north wall of Room B02. Note boards at ceiling.

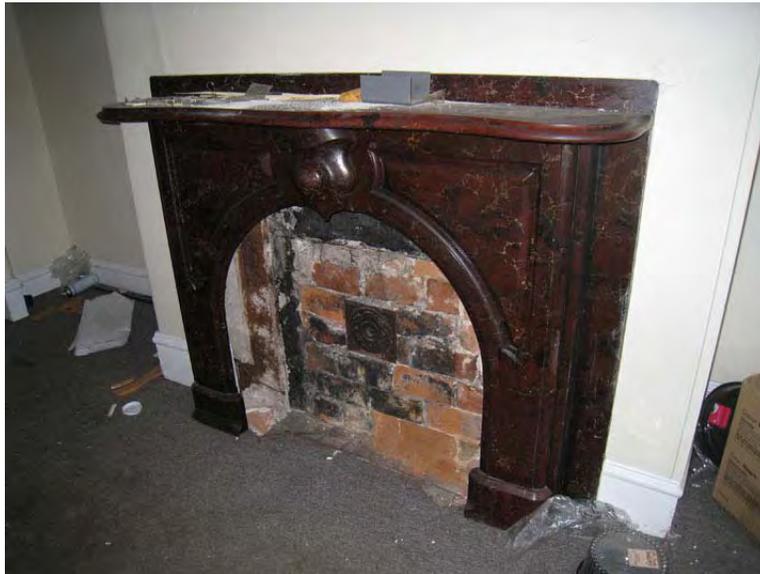
There is a fireplace built into the north wall of the space with a marble mantel and surround. The interior of the fireplace was formerly infilled with plaster, but the plaster has been removed, exposing a brick wall constructed across the firebox opening. At the center of this wall is a 6 1/2" x 7 1/4" iron door (Photo 2.2-38).

Photo 2.2-38: Fireplace surround in Room 105.

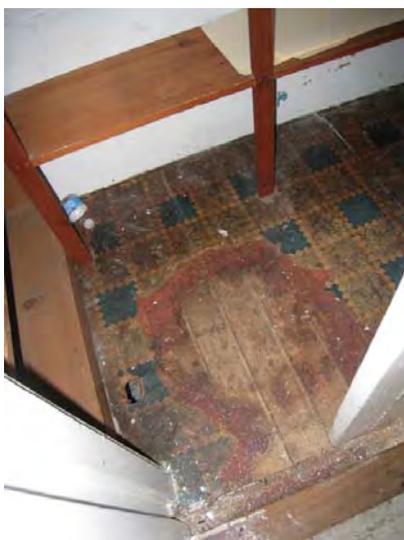
Photo 2.2-39: Worn linoleum floor at Room 109 closet.

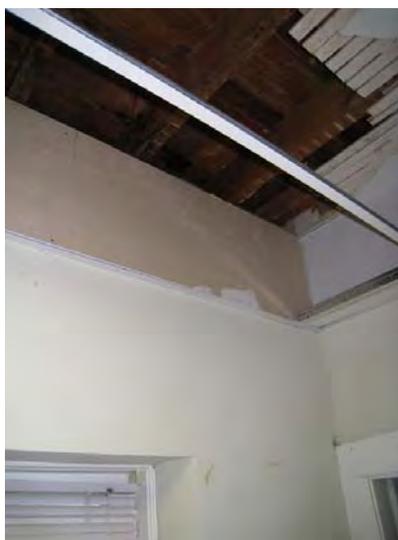
Photo 2.2-40: Furred-out drywall wall at north side of room. Note line of ceiling grid and area of removed plaster ceiling above.

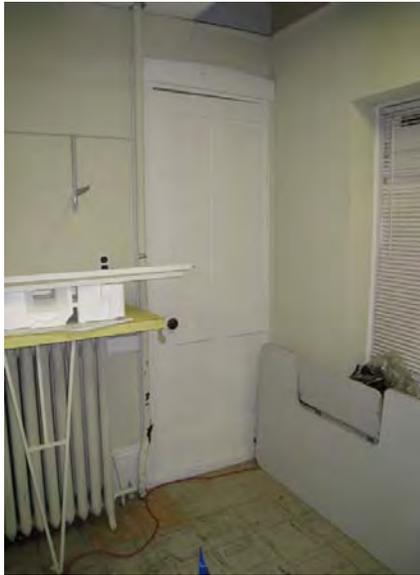
Photo 2.2-43: Door into closed-in back stairs at north corner of west wall. Door has been fixed shut.

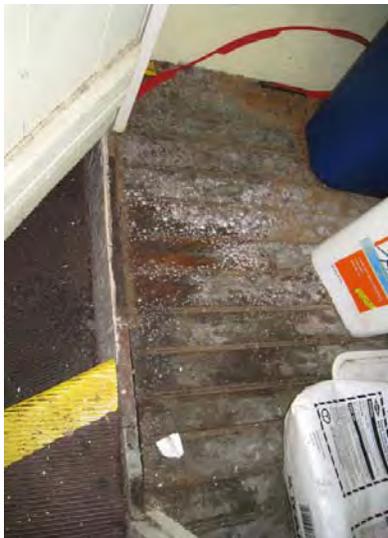
Photo 2.2-45: Mold at floor boards in Room 110A. Also note vinyl cover at adjacent stair tread.

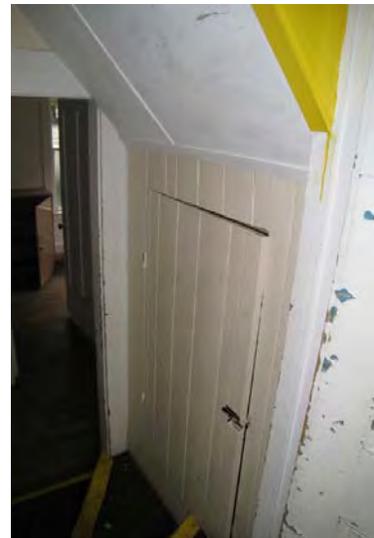
The door opening between Room 110A and Room 110B is 2'-2 3/4" wide and 4'-0" tall and is composed of the same random width beadboard as the surrounding wall supported on bracing at the interior side of the door. Hardware consists of hinges and a surface-mounted latch (Photo 2.2-47).

Photo 2.2-47: Door to Room 110A.

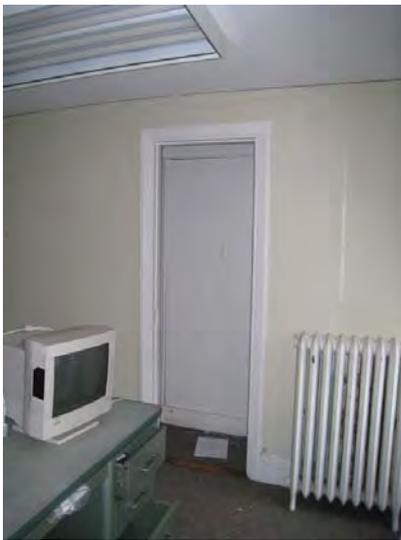
Photo 2.2-48: North wall in Room 205 built out from original plaster wall. Note closed in door opening at back of closet.

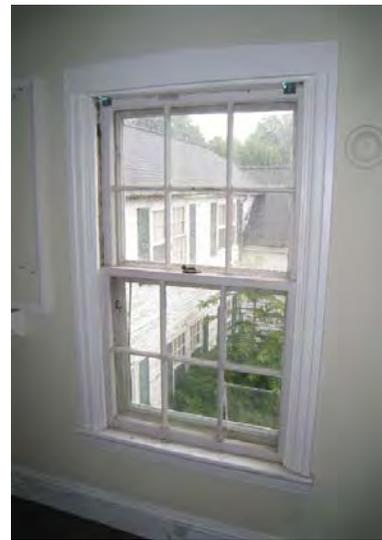
Photo 2.2-50: Detached glass pane at south window of Room 205.

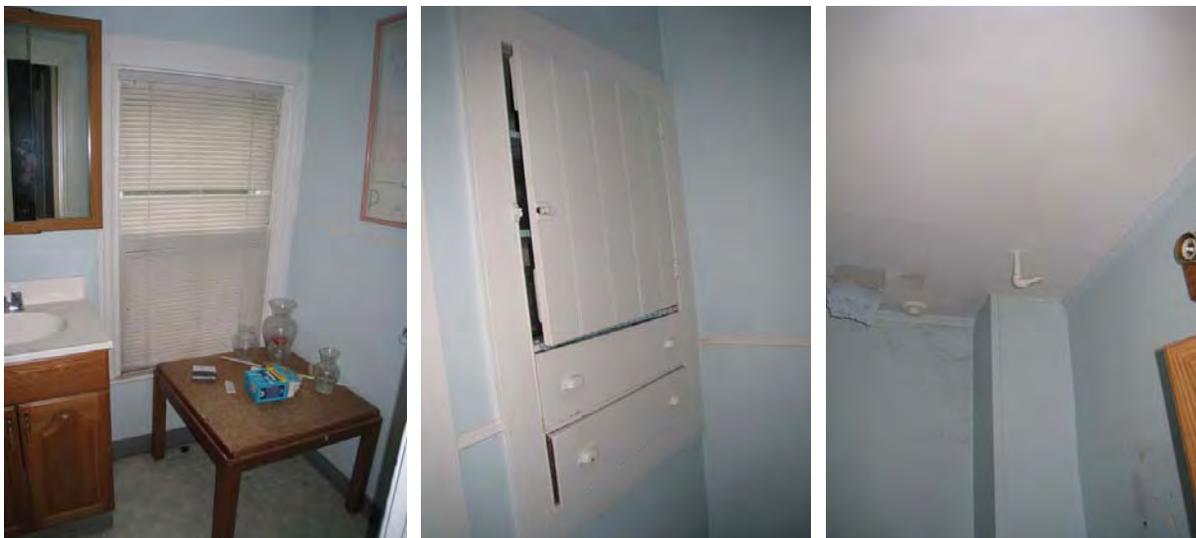
Photo 2.2-51: Northeast corner of Room 208: Note change in plane at east wall.

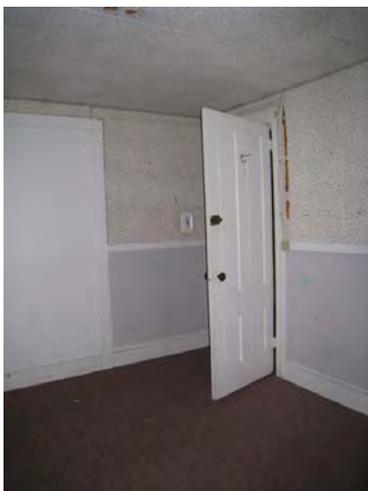
Photo 2.2-54: Overall view of Room 109 showing plaster wall below, pegboard above. Closed-in door to Room 205 is at left.  
Photo 2.2-55: Water damage at window sill and wall below.
