Historic Structure Report  
**The Hammond A. Hosmer House**  
Lexington, Massachusetts  
BH+A Project No. 2991.00

Prepared by: Bargmann Hendrie + Archetype, Inc.  
300 A Street  
Boston, MA 02210  
617-350-0450

Prepared for: Town of Lexington  
Department of Public Facilities

November 30, 2010

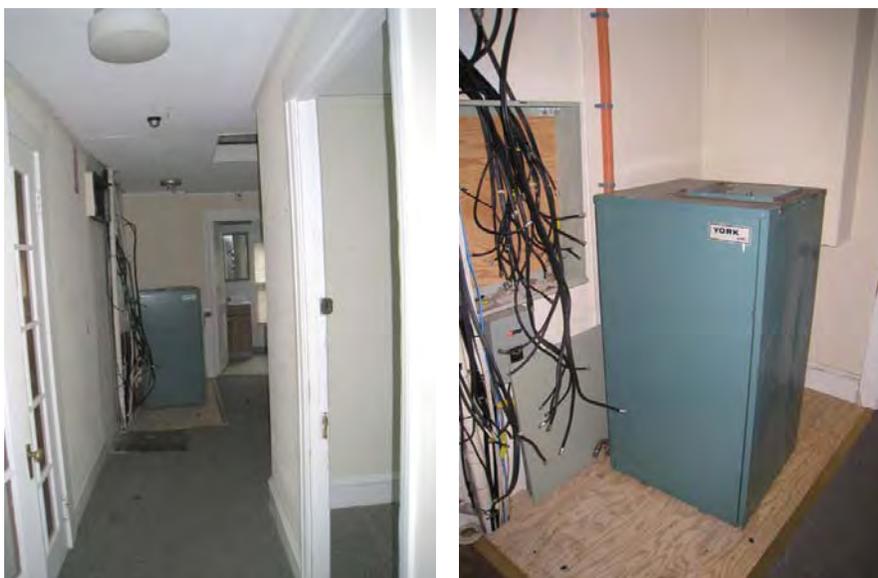
The north ell corridor floor consists of grey-wall to wall carpet. An area of missing carpet near the northwest side of the space reveals linoleum below. Plywood is installed at the northwest corner to close in the previous back staircase and provide support for mechanical equipment (Photo 2.2-56).

The walls in the corridor are painted plaster in fair condition. A large amount of piping and wiring, as well as a metal panelbox is fastened to the west wall adjacent to the mechanical equipment at the northwest corner of the space. In addition, a vent has been inserted through the wall into room 207.

Photo 2.2-56: Overall view of Room 210 showing mechanical equipment at northwest side, vent into Room 207 and attic access hatch.

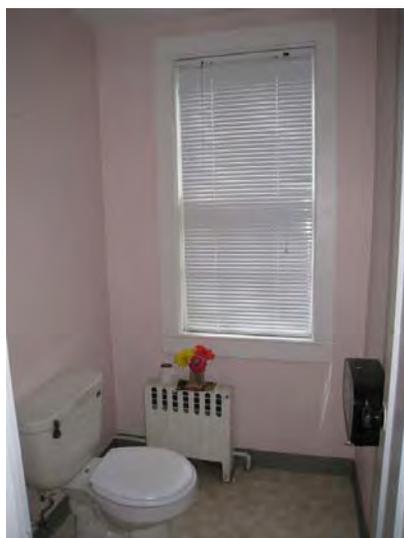
Walls in rooms 107 and 108 appear to be painted plaster in fair condition (Photo 2.2-60). There is no trim except for a 4" high vinyl base. Ceiling construction is unknown, and might be plaster or drywall. The ceiling in the space is low (7'-8") compared with ceiling heights in adjacent spaces.

Photo 2.2-60: Overall view of Room 107.

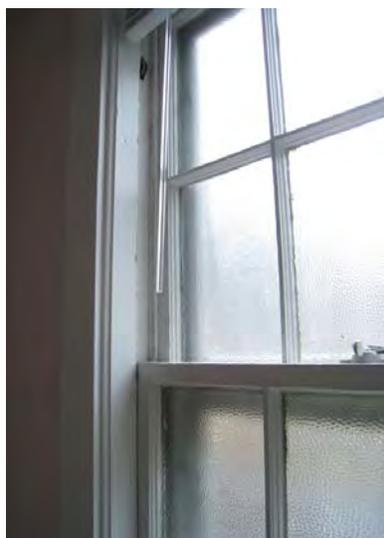
There is an additional window at the north wall of Room 107. The window is a 6-over-6 double hung with textured, frosted glass (Photo 2.2-61). The window is in fair condition, but the ropes to operate the lower sash have been removed. Window trim consists of 3 1/2" flat painted wood boards.

Photo 2.2-61: Window in Room 107. Note removed sash rope at window jamb.

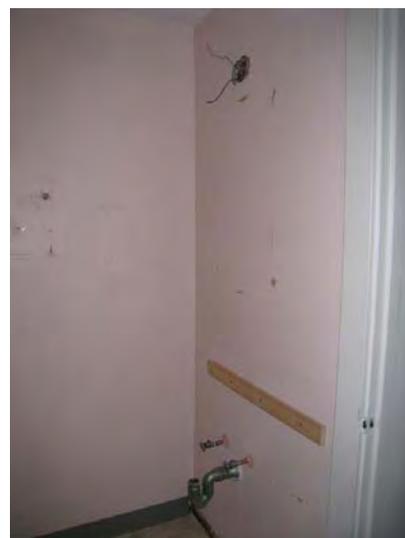
Photo 2.2-62: Removed sink and light fixture in Room 108.

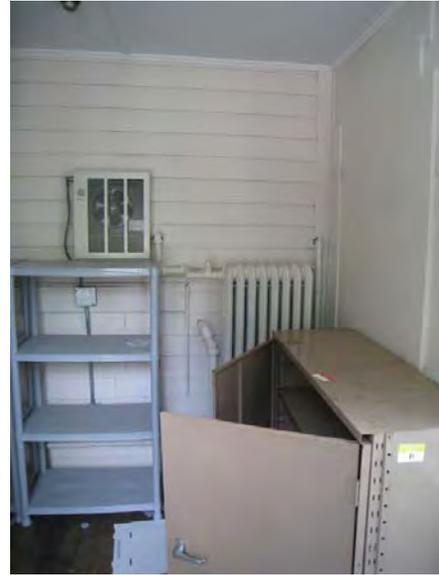
The north and west walls of Room 112 are painted wood panels with thin (1 3/4" wide) strips of raised wood trim between panels. The panels are in good condition. The south wall of Room 112 is painted exterior clapboard siding with a 5" exposure (Photo 2.2-64). The siding is in good condition.

Photo 2.2-64: Exterior clapboard siding at south wall of Room 112. Note closed-in door at west wall.

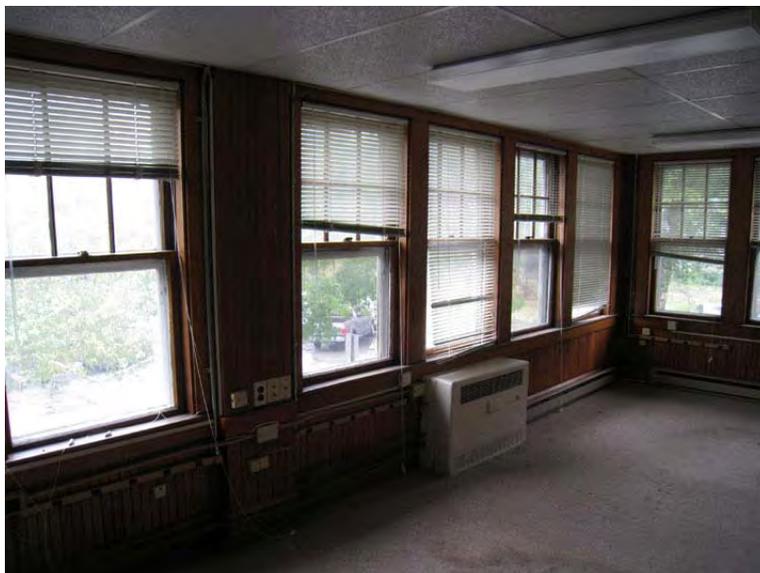
The walls in rooms 207 and 206 are covered with varnished 3 1/4" wide tongue-and-groove wood beadboard (Photo 2.2-67). The wood is in good condition except at the northeast corner of the room where there is some water damage at the top of the wall. Squirrels have chewed a hole in the top of the east wall at the corner and nesting material has fallen into the room (Photo 2.2-68).

Photo 2.2-67: Overall view of Room 207.

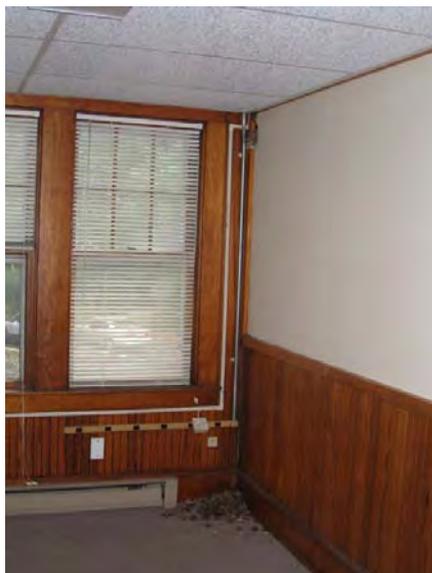
Photo 2.2-68: Squirrel hole, north corner of east wall.

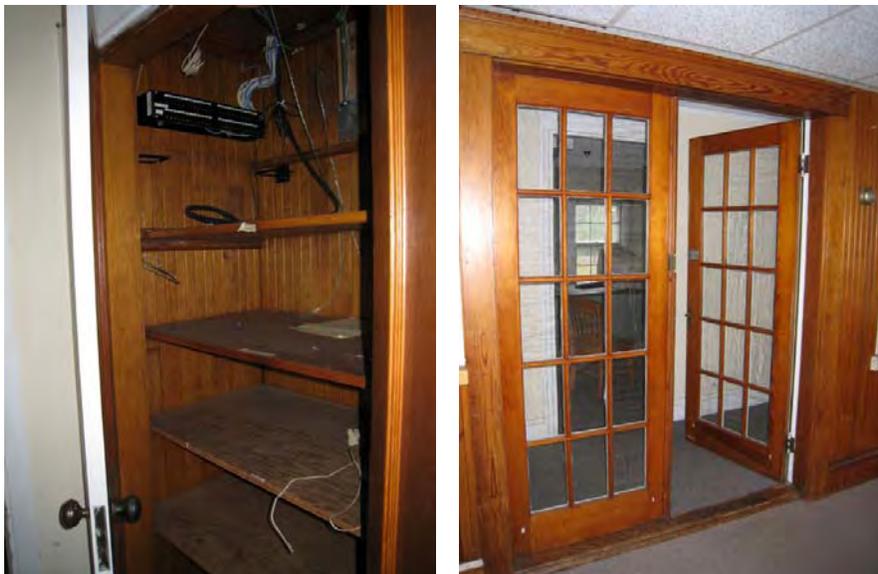
The walls and ceiling of Room 206 are also varnished beadboard in fair condition. Numerous holes for wiring have been made in the back wall of the closet.

Photo 2.2-70: Room 206 (closet) interior.

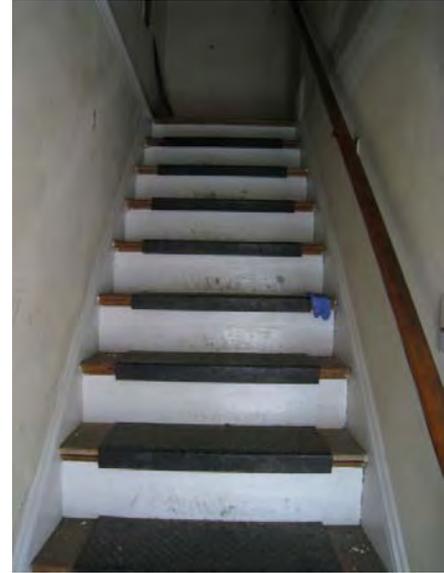
The stairs leading from Room 113 to the second floor have wood treads and painted wood risers in good condition. The treads are 9 1/4" wide and the risers are 8" high (Photo 2.2-75). Vinyl tread covers are installed at the stairs, which are in poor condition. A modern wood rail is mounted to the wall at the south side of the stairs. The rail is in fair condition. The stairs leading from Room 109 to the lower portion of Room 113 are carpeted. The treads are 11" wide and the risers are 7 3/4" high.

Photo 2.2-75: Stairs to second floor.

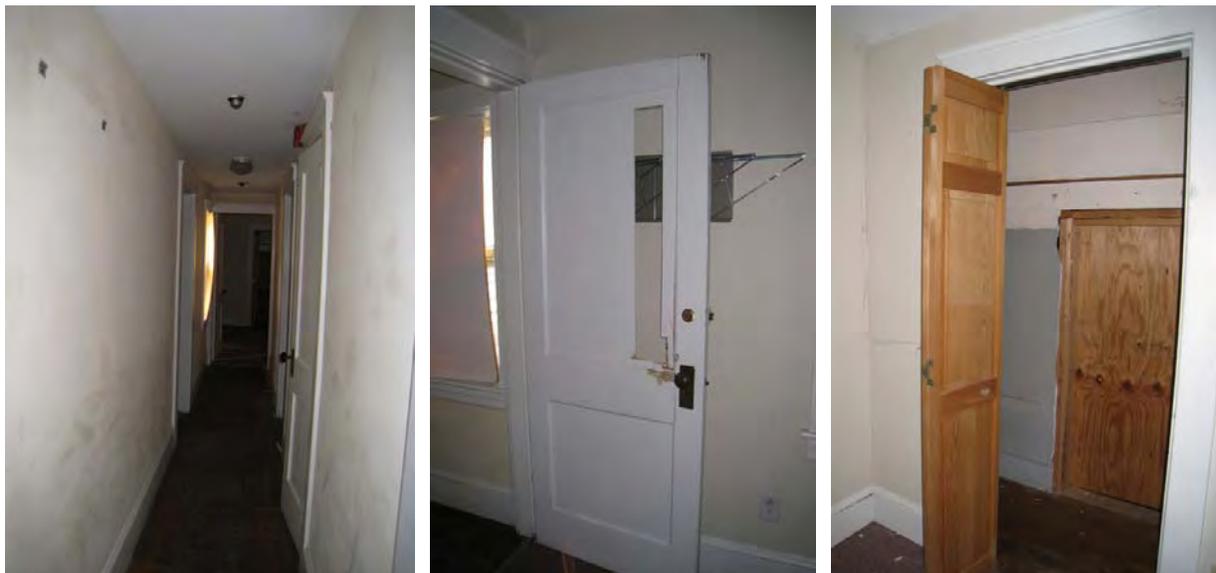
Photo 2.2-85: Broken vision glazing and damaged wood panel at door between rooms 214 and 211.

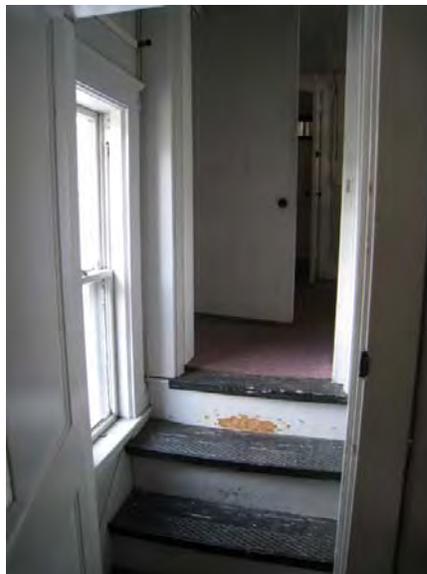
The connecting stair between rooms 212 and 209 consists of 10 1/2" wide treads with 9" high painted wood risers. The treads are covered with vinyl that is in fair to poor condition. The paint finish at the risers is in poor condition (Photo 2.2-88).

Photo 2.2-88: Stairs between rooms 212 and 209.

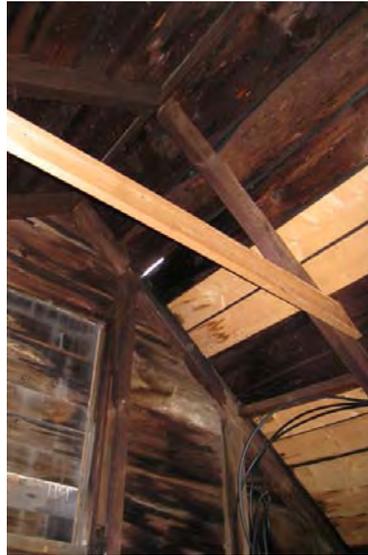
Photo 2.2-98: Open area at roof, the cause of the active leak. Note water damage at sheathing members (and presence of replacement sheathing boards).
